GAS EXPLOSION LEVELS MANSION OUTSIDE OF PHILADELPHIA

206 Springdale Lane, in Millersville, Pennsylvania

MECHANICAL TAP TEE INSTALLATION

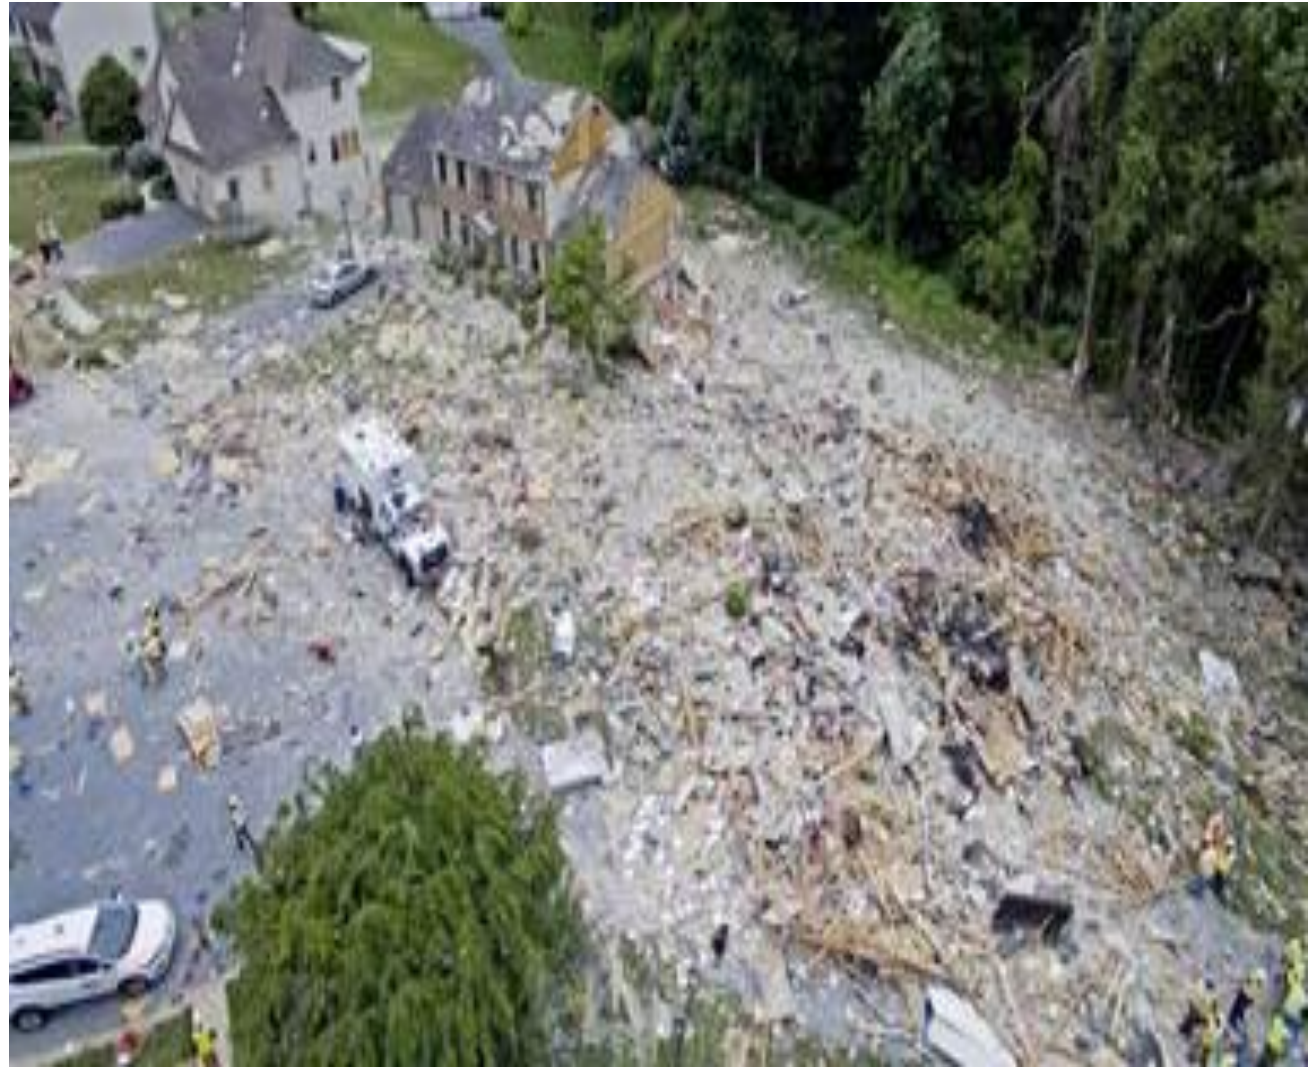
54-year-old Richard Boudier, was killed in the blast, and three other people were injured when a home on the 200 block of Springdale Lane in Manor Township exploded.

Technicians were responding to reports of a natural gas leak and excavating a location near the Manor Township home before it exploded,

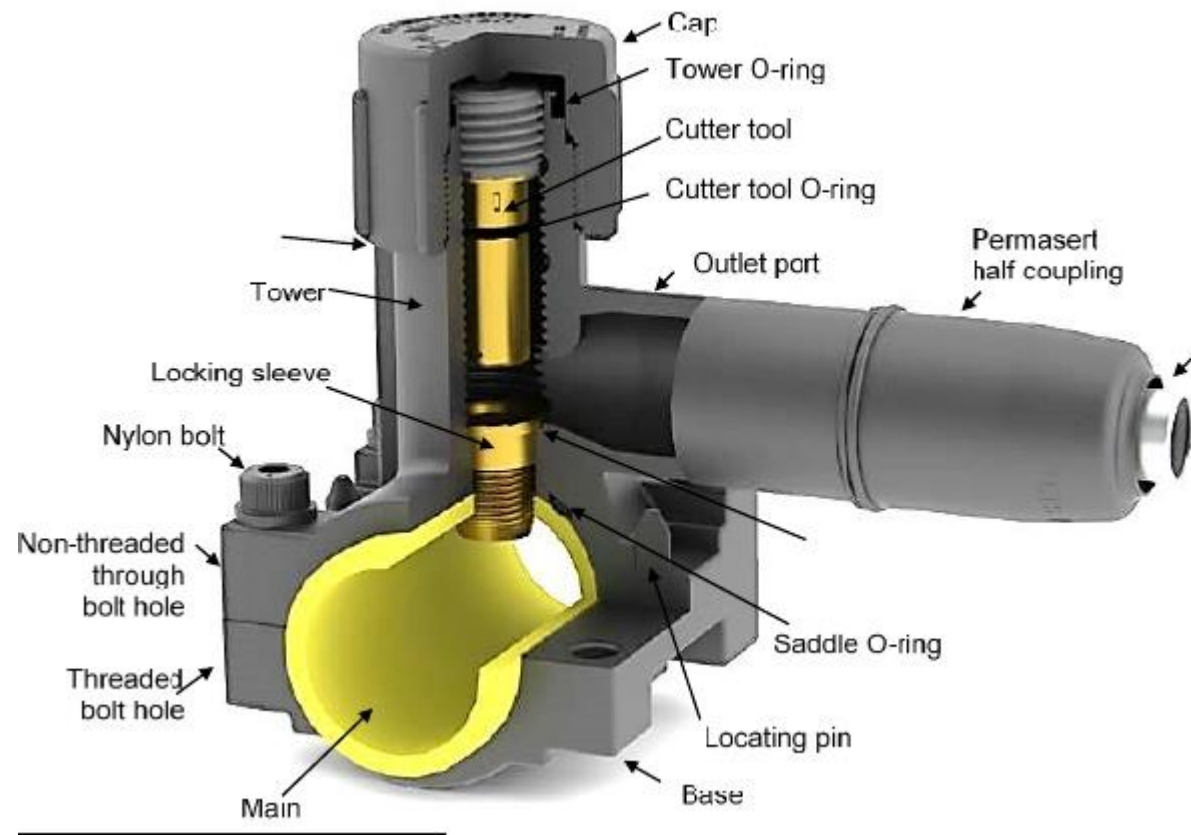
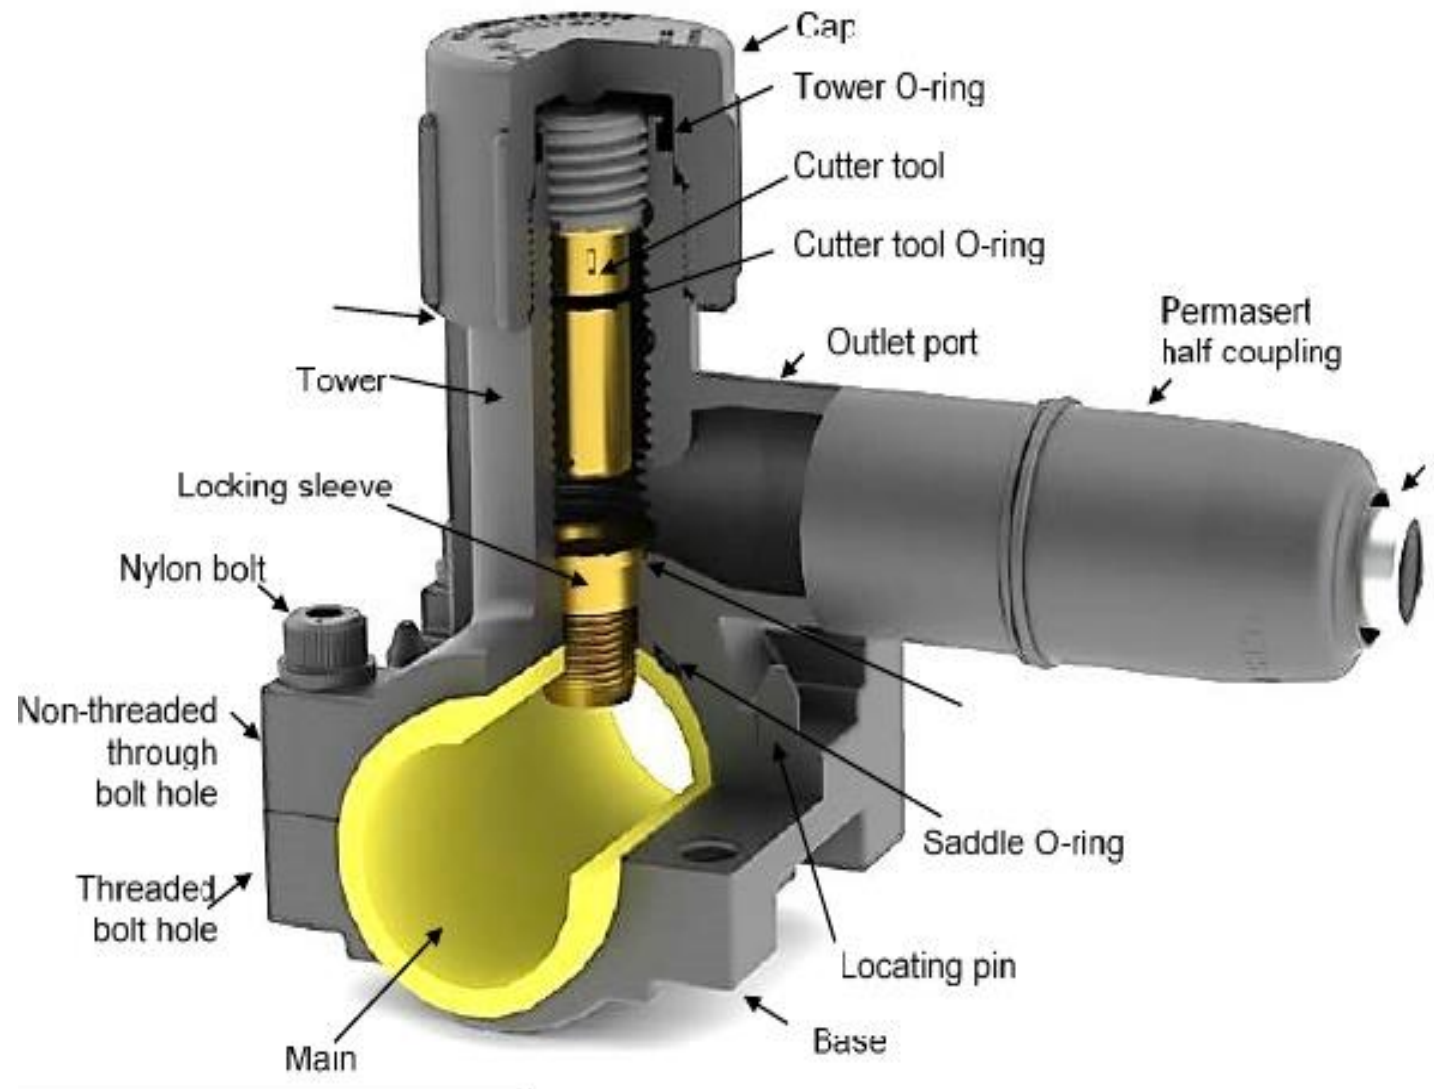
PERMALOCK

After the explosion, investigators pressure tested the main and service lines at the accident site and determined that the PermaLock mechanical tapping tee assembly was leaking gas at the connection of the tee assembly to the main in front of the destroyed home.

An NTSB examination of that PermaLock tee revealed the tee assembly was incorrectly installed. According to the report, UGI installed the tee assembly in June of 1998 and it had been in service for 19 years when the accident occurred.

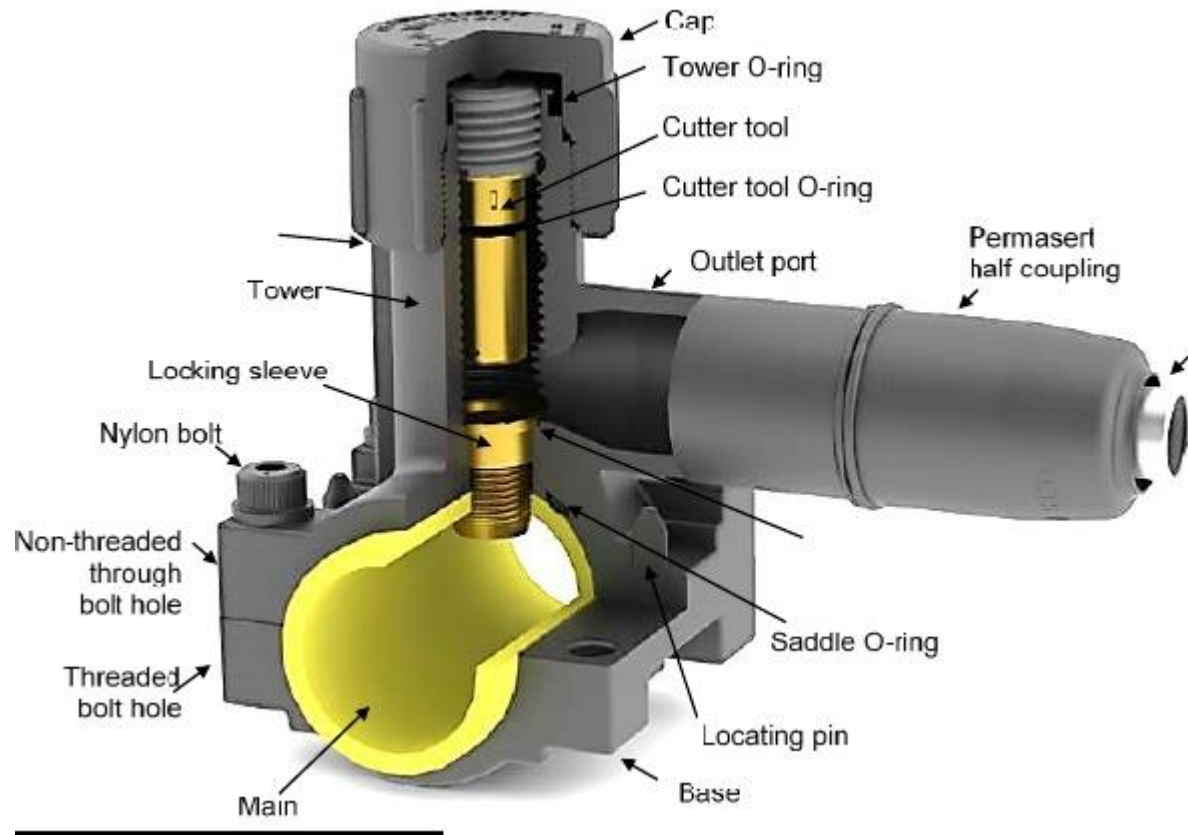
MECHANICAL TAP TEE

- NTSB examination of the PermaLock tee assembly involved in the accident has revealed that the tee assembly was incorrectly installed.
 - Although the cutter tool pierced a hole in the main, the locking sleeve did not progress down far enough into the tower to form threads in that hole.
 - As a result, the locking sleeve was not attached to the main.
 - The NTSB also found that two of the four Nylon bolts on the tee assembly were fractured in a manner consistent with *slow crack growth*

For tee assemblies with a locking sleeve, such instructions must specify

- (1) the exact tools that are most effective for attaching a locking sleeve to a main and
- (2) the use of a depth tube to verify that attachment
- (3) not-to-exceed torque limit for Nylon bolts and have that value checked and adjusted with a torque wrench immediately after installation..

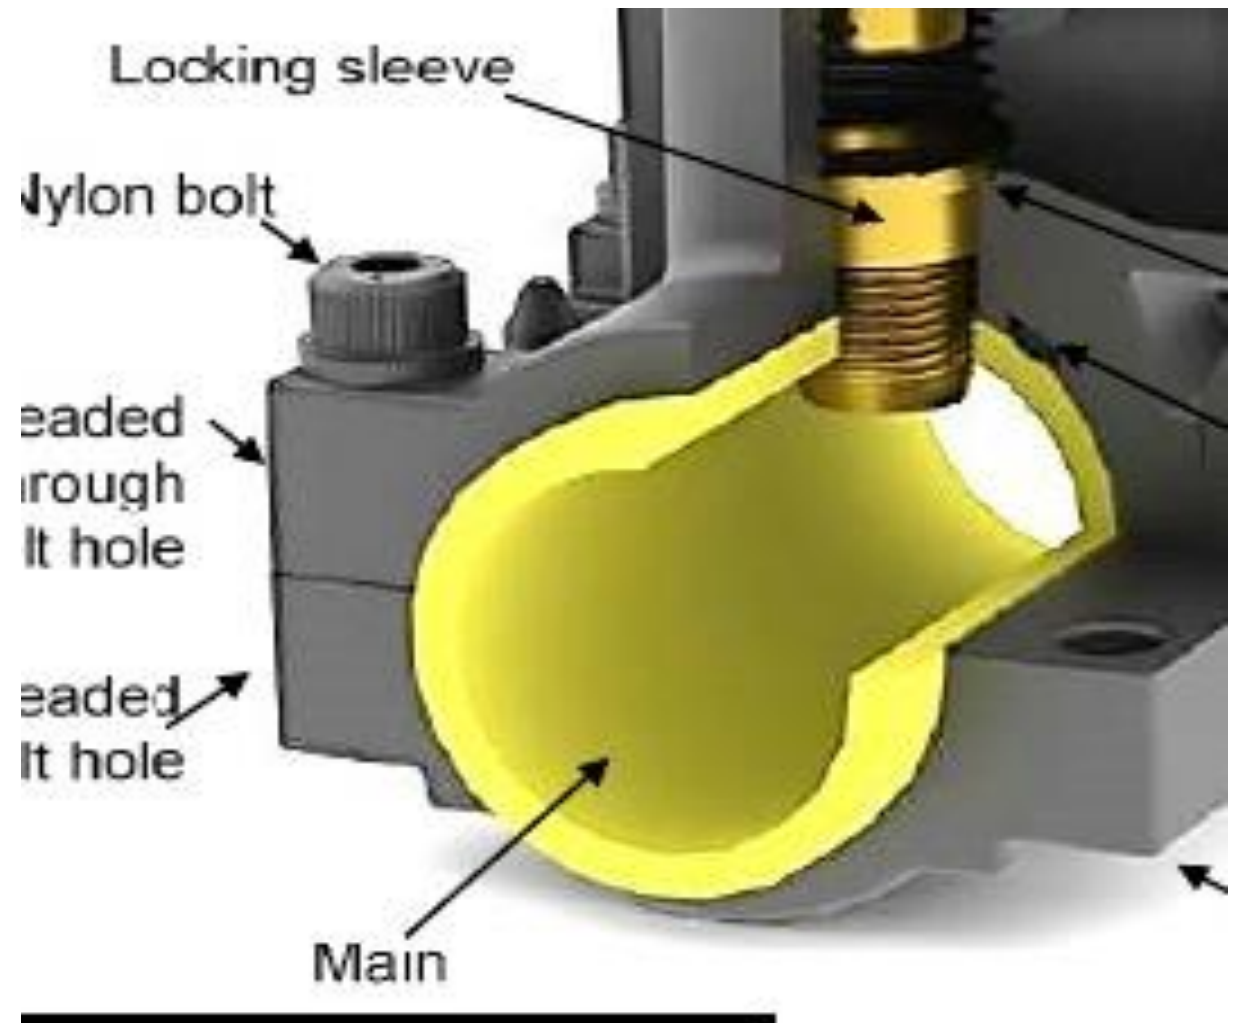
- An incorrectly installed tee assembly can leak gas several months, years, or decades after installation.
 - ADB-08-02 in 2008

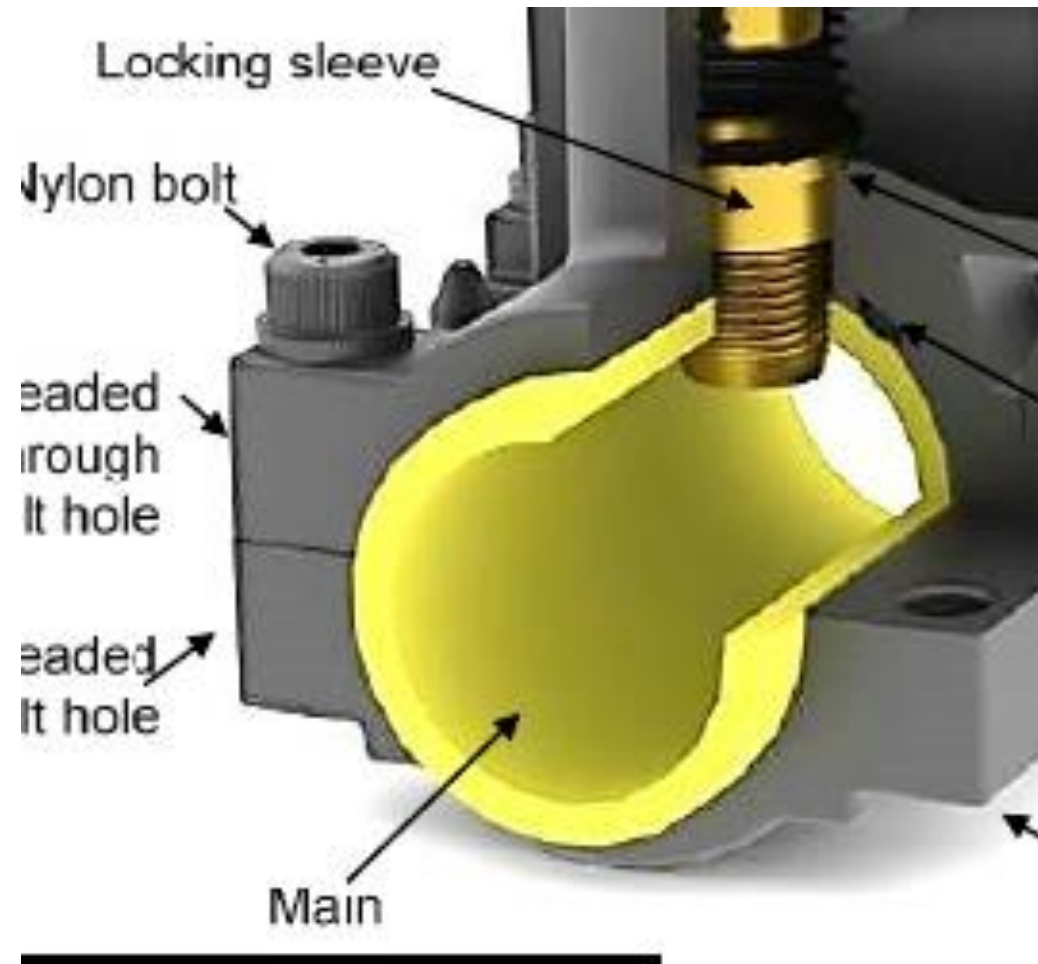
- There are multiple modes of failure for this assembly.
 - Locking sleeve not positioned correctly
 - Crack upon Nylon bolt
 - Failed (fractured) Nylon bolt
 - Multiple Nylon bolts fractured

ALSO remember that if the assembly is found to be leaking, this now is a Mechanical Fitting Failure, must be tracked and reported as a mechanical fitting failure.
