## **Nebraska State Fire Marshal Pipeline Safety Section Investigation Report**

**INCIDENT INVESTIGATION**

**Black Hills Energy**

**Geneva**

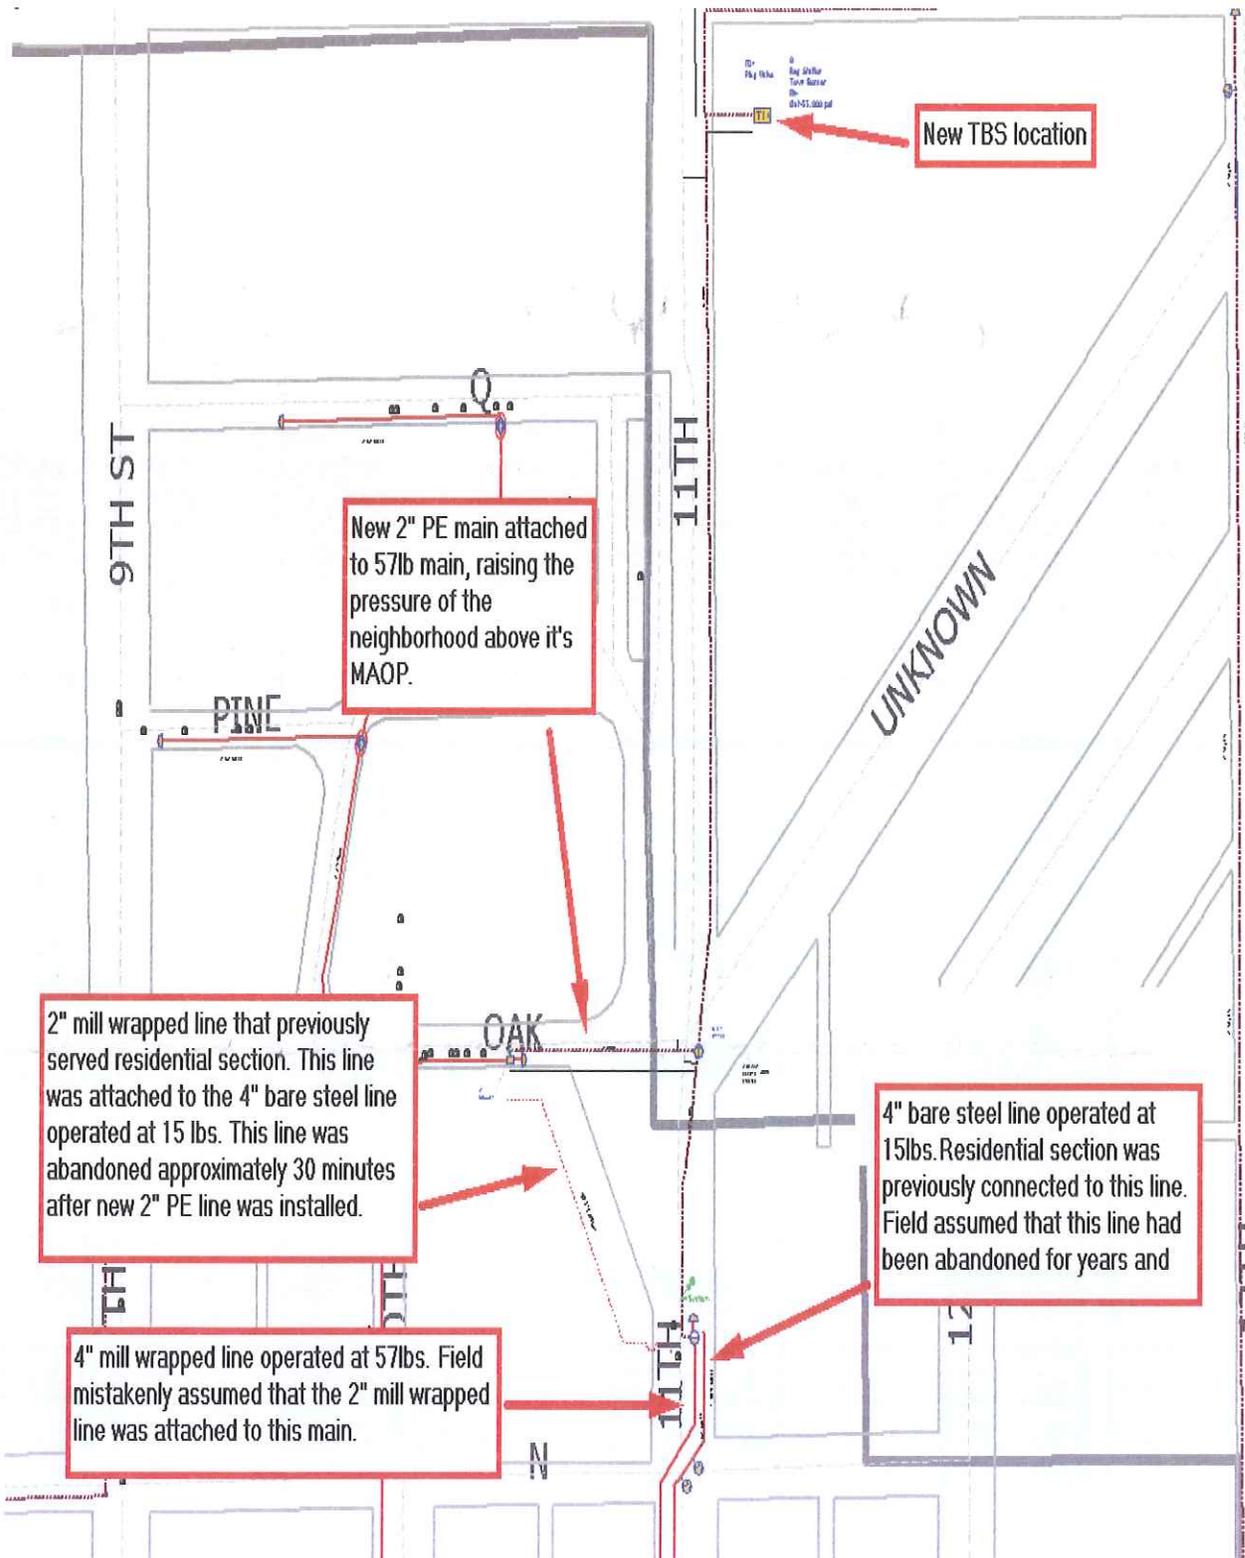
New TBS location

New 2" PE main attached to 57lb main, raising the pressure of the neighborhood above it's MAOP.
