Nebraska State Fire Marshal Pipeline Safety Section Investigation Report

INCIDENT INVESTIGATION

Black Hills Energy

Geneva

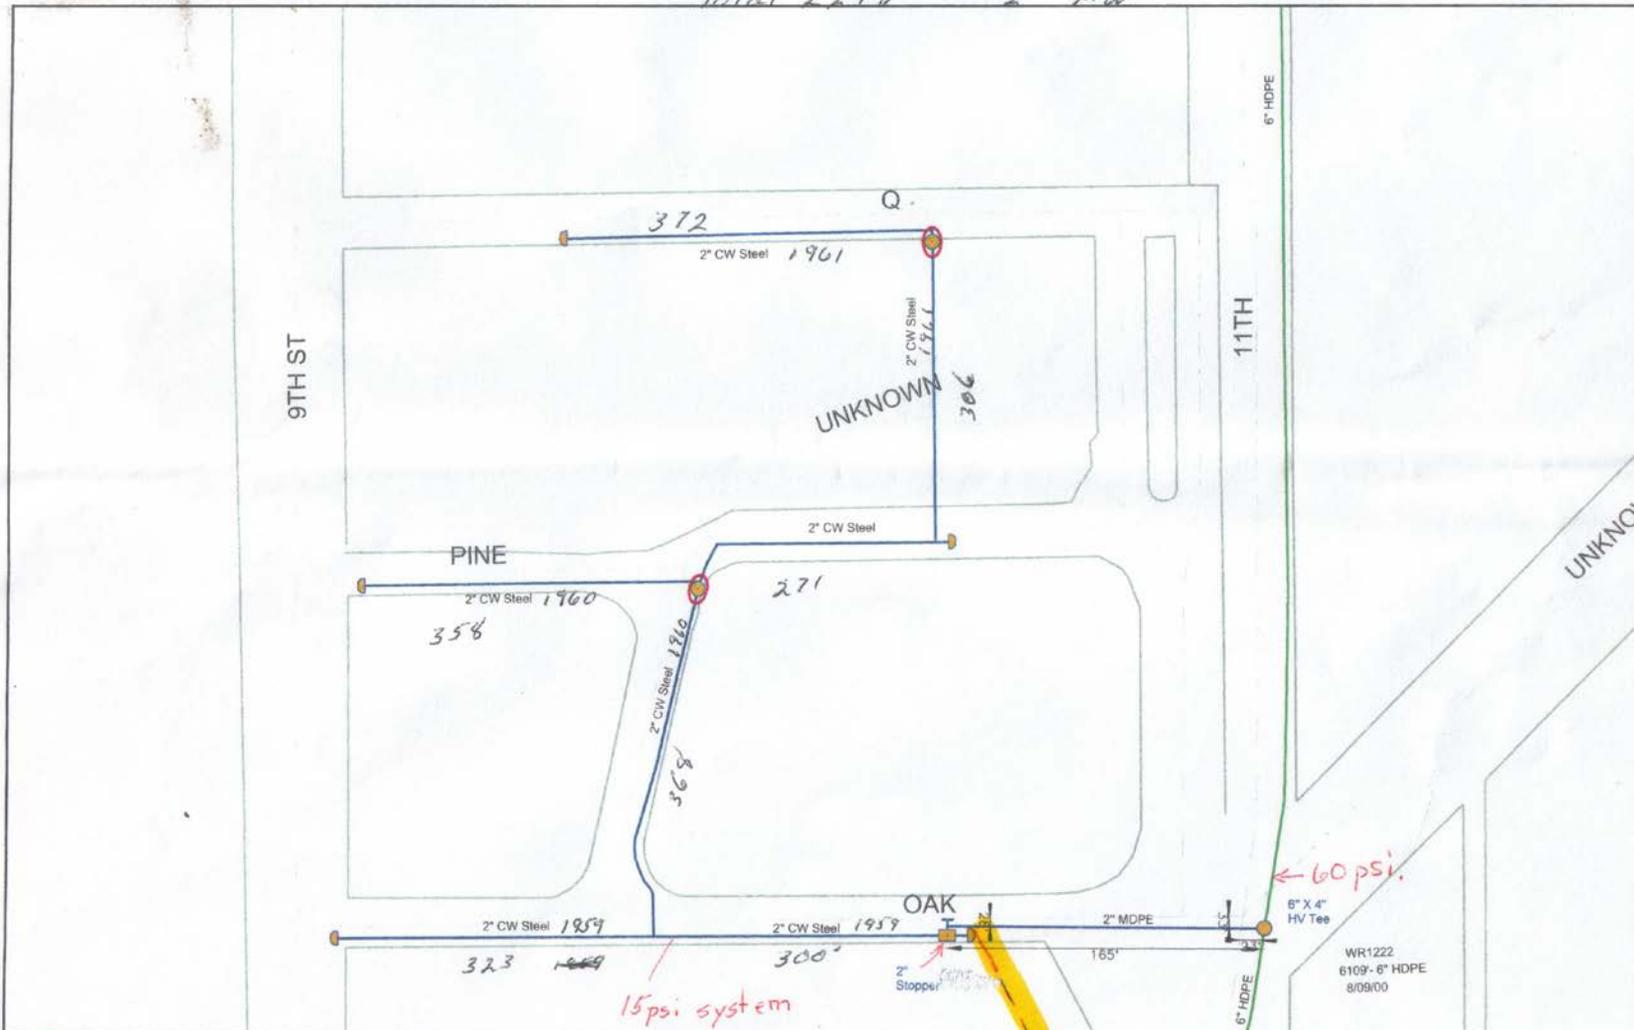
Total 2298 2" MW
