# Pipeline and Hazardous Materials Safety Administration (PHMSA)

### Accident Investigation Division (AID)

Nebraska State Fire Marshal Pipeline Safety Seminar

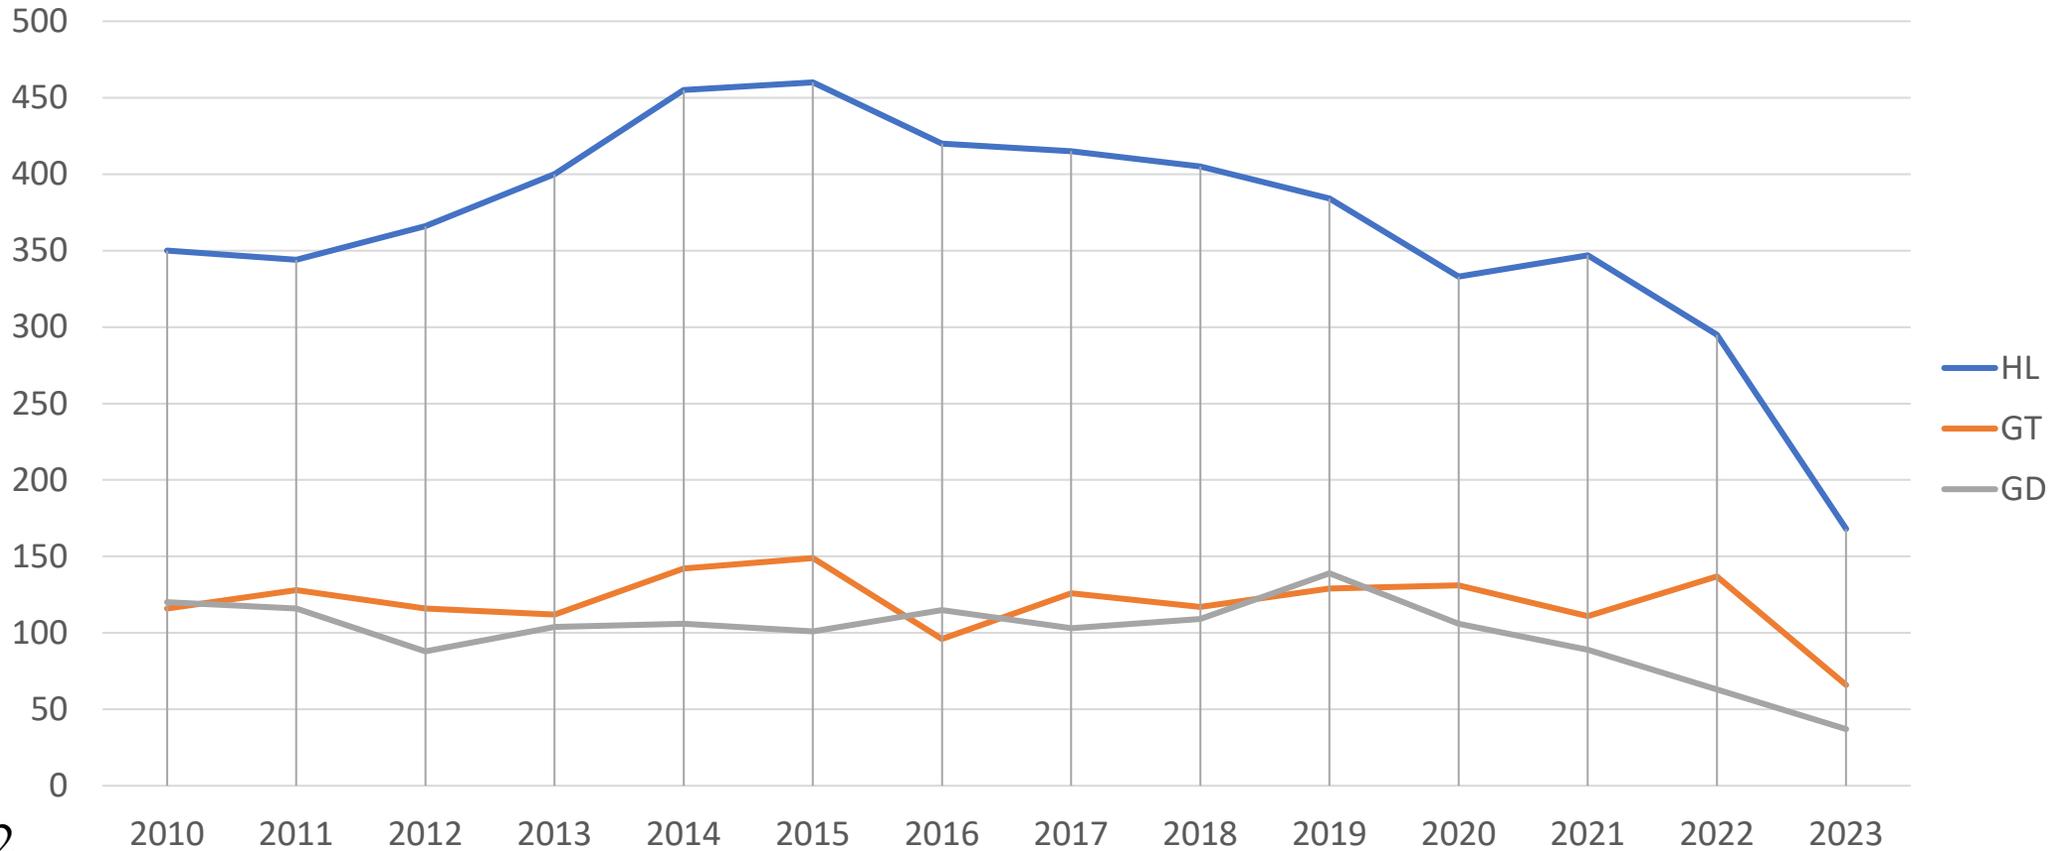
# Number of Reportable Accidents by Year (2010 – August 2023)

HL: 5,142  
 GT: 1,676  
 GD: 1,396

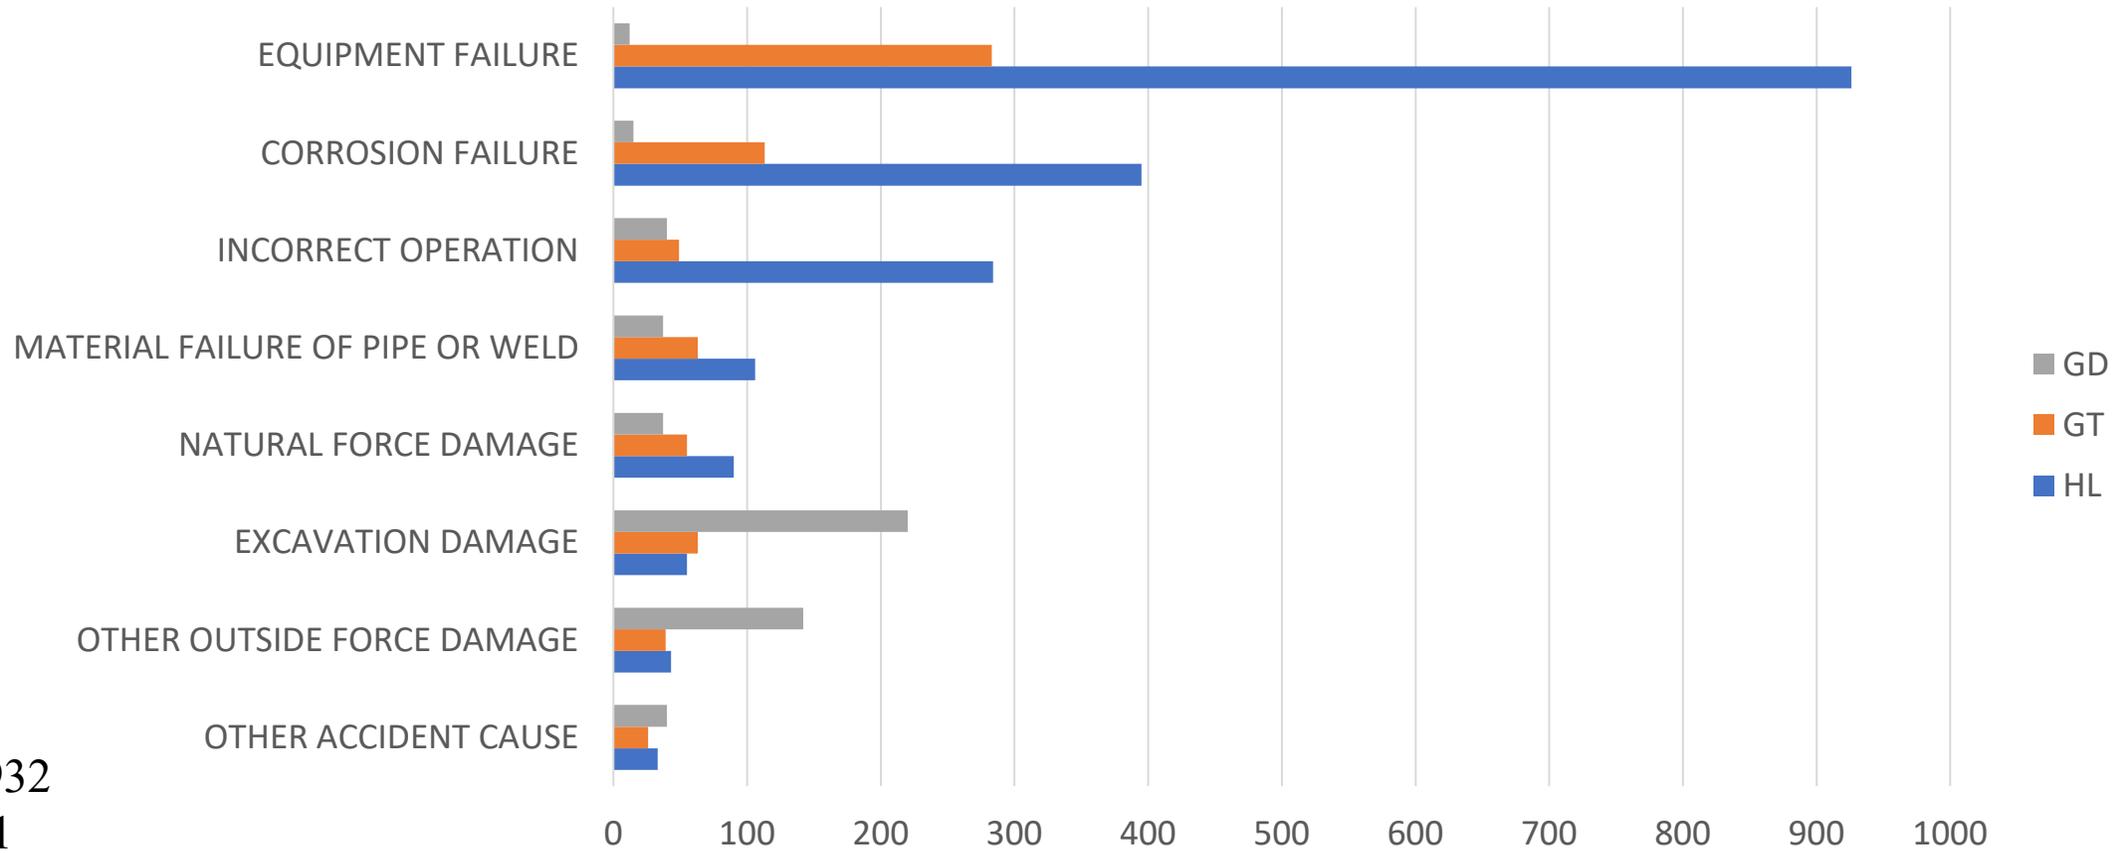
# Number of Reportable Accidents by Cause (2018 – August 2023)

HL: 1,932

GT: 691

GD: 543

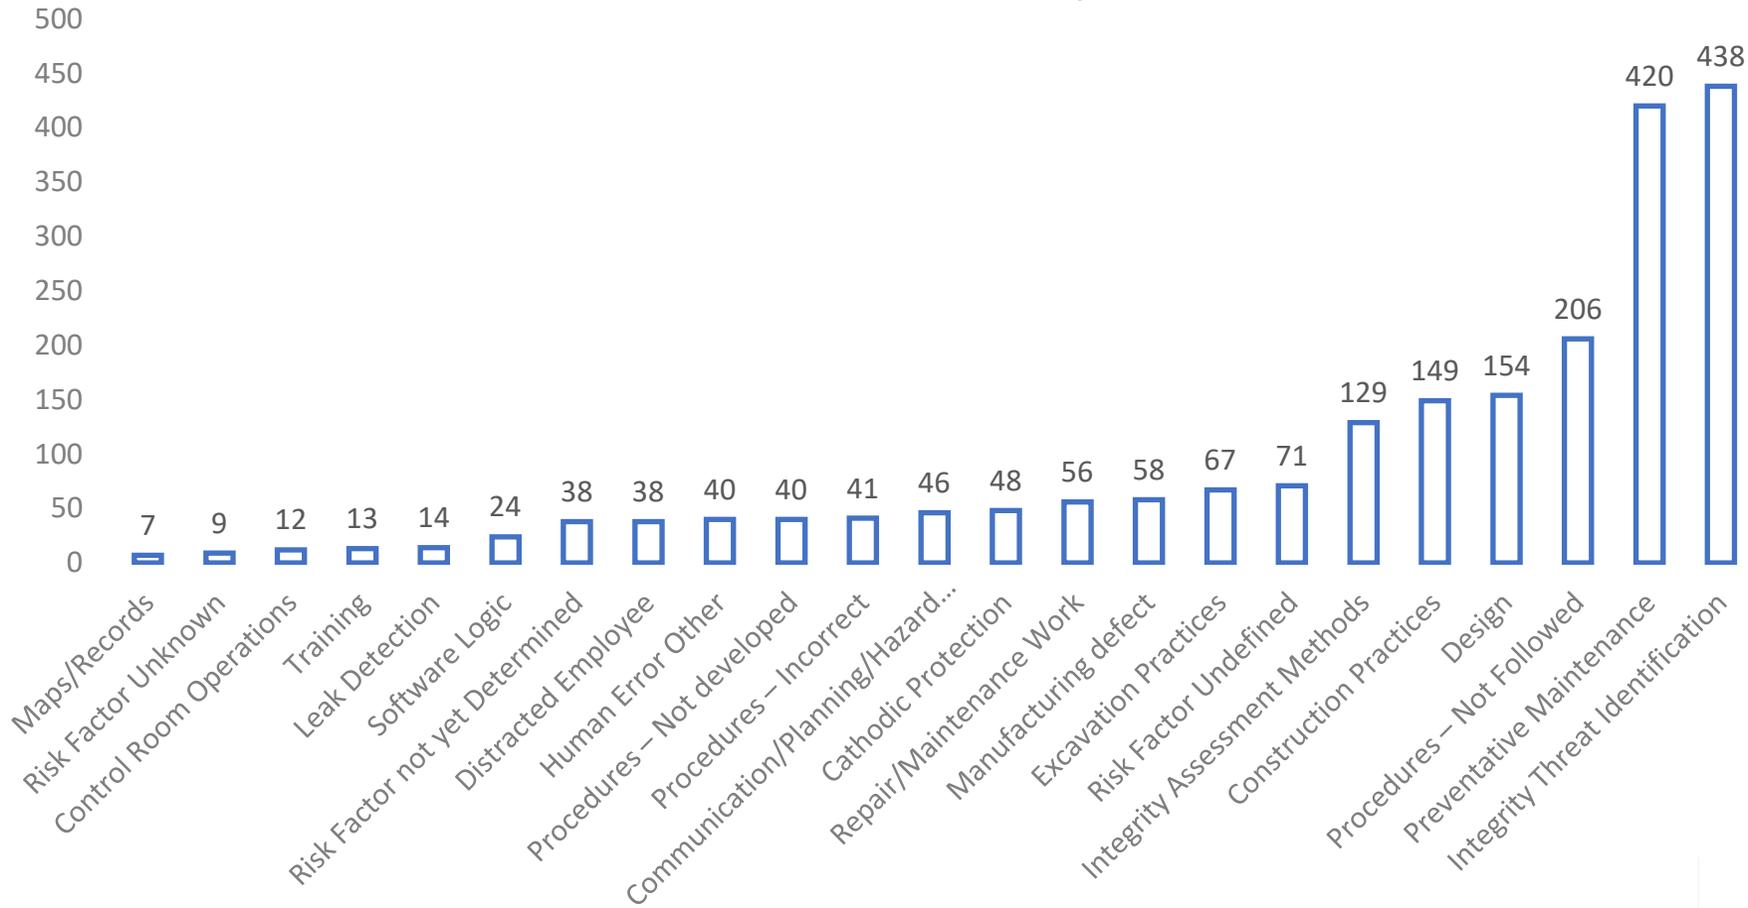
# Risk Factors

## Failures 2018 – January, 2024

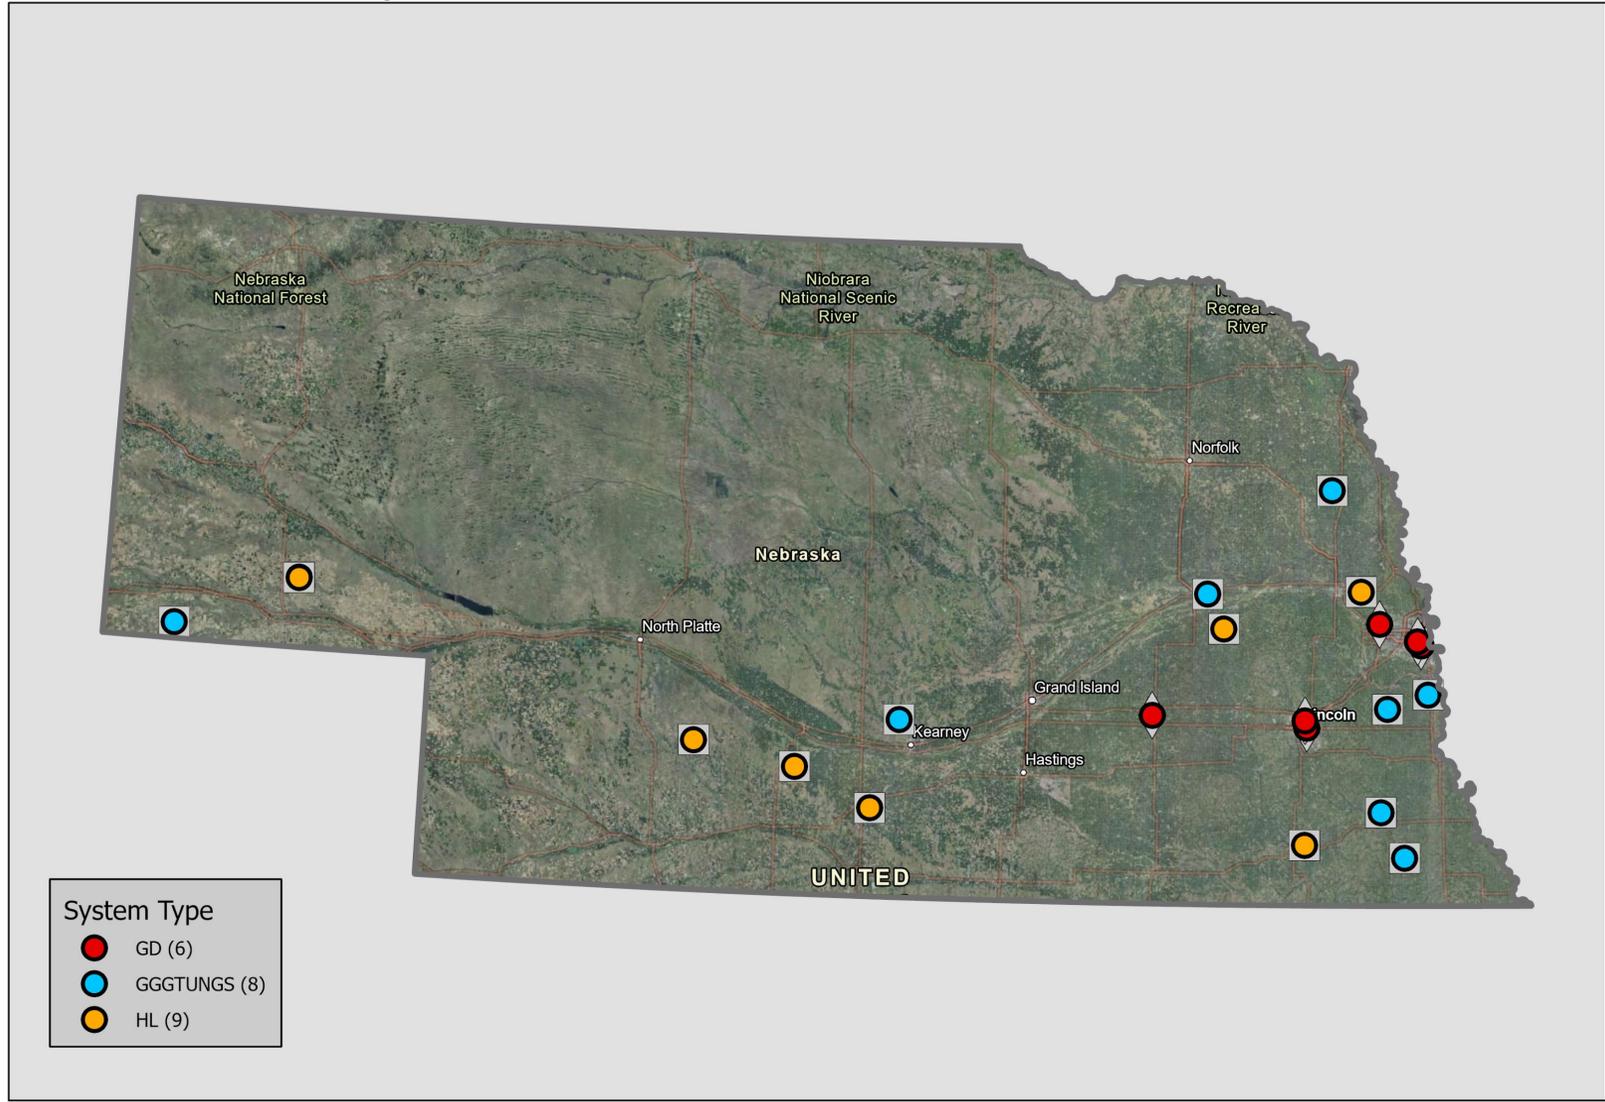
# Pipeline Failure Locations in Nebraska, 2018 - Present

- System Type**
- GD (6)
  - GGTUNGS (8)
  - HL (9)

Jurisdiction  OPS Regulated  State Regulated

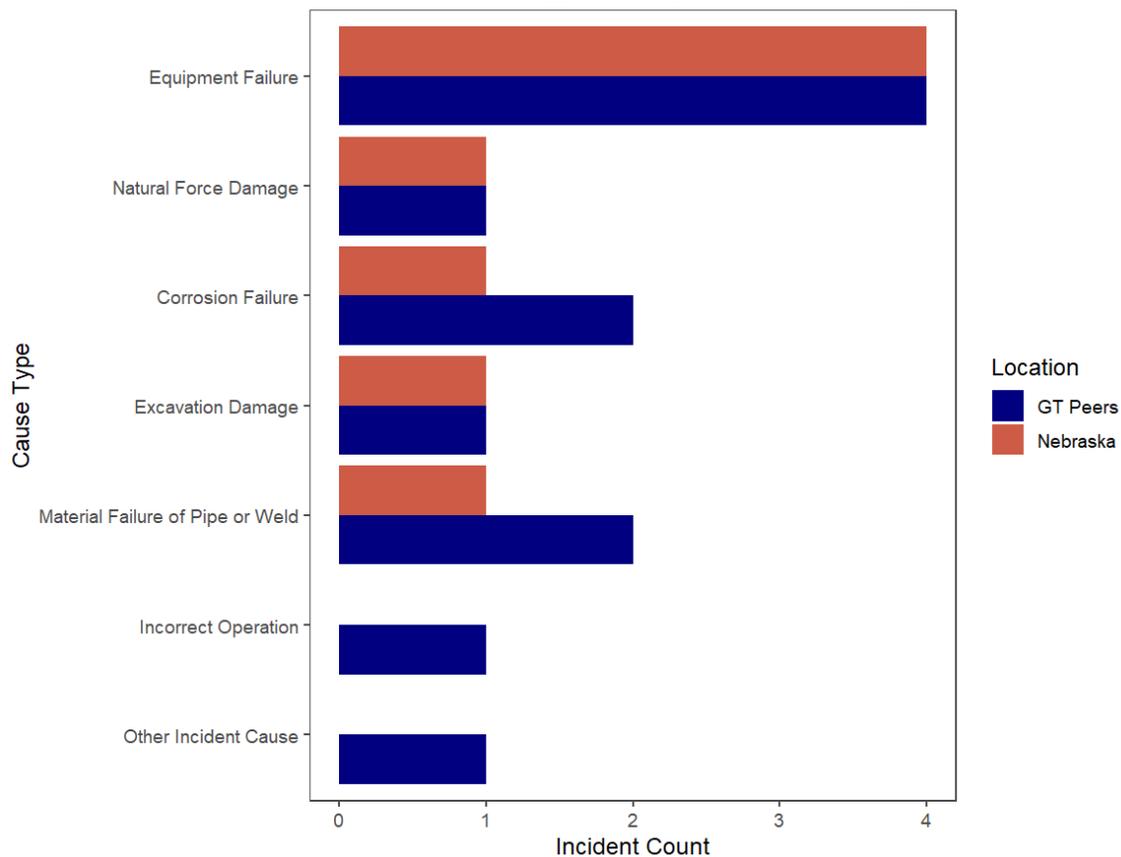
Nebraska Cause Types Compared to the Average for 4 GT Peers

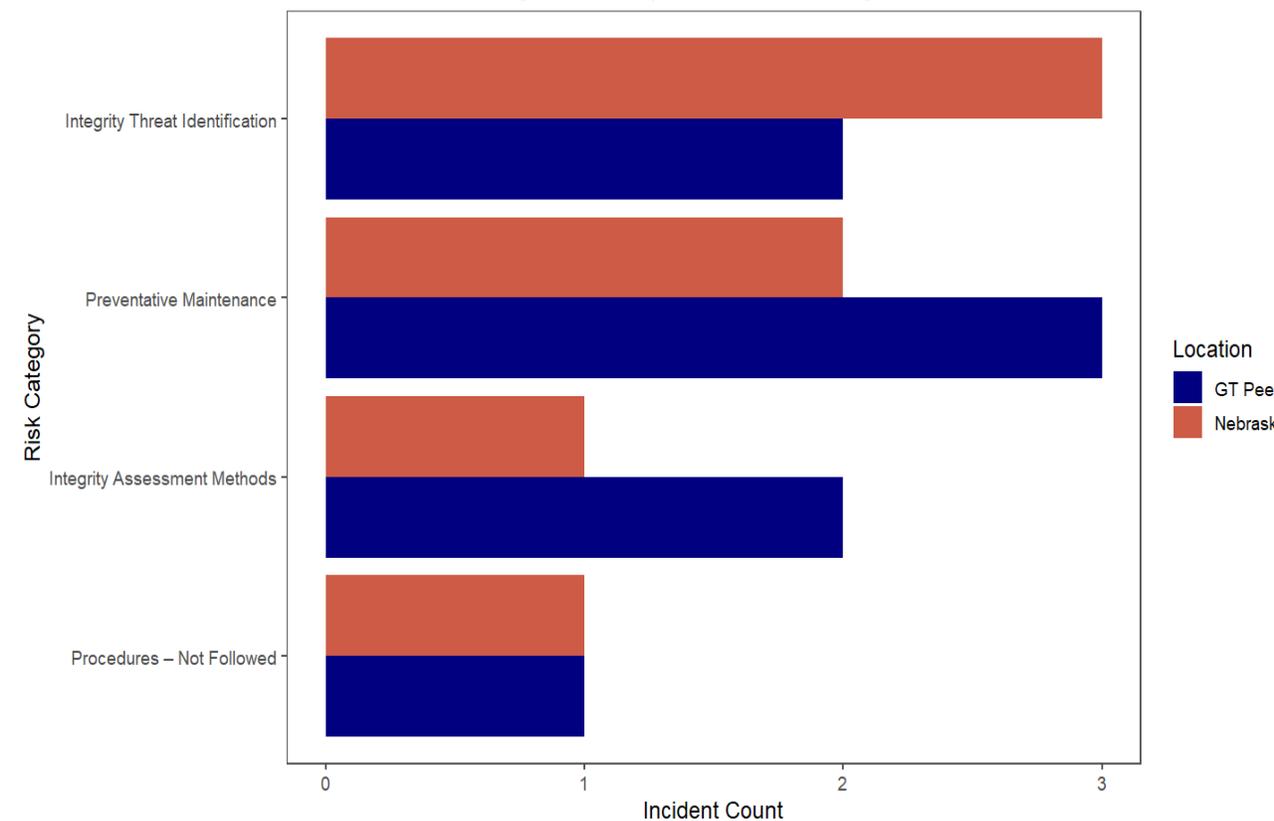
Nebraska Risk Categories Compared to the Average for GT 4 Peers

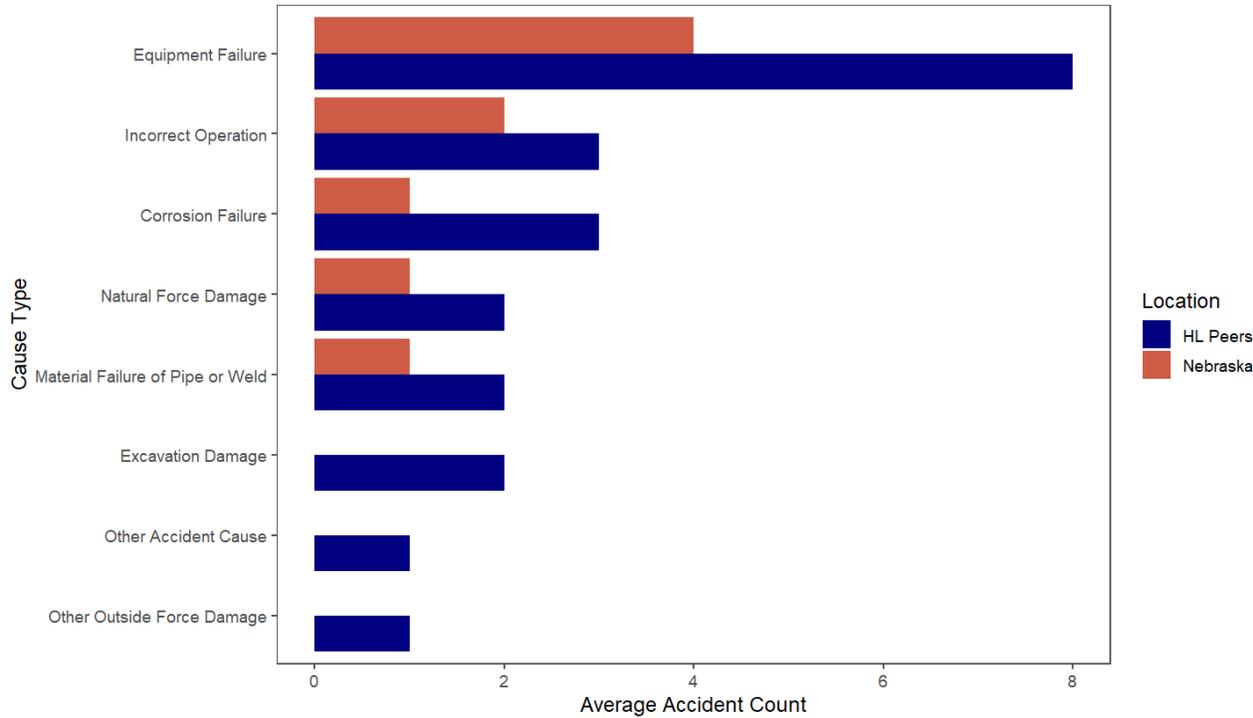
Nebraska Cause Types Compared to the Average for 4 HL Peers

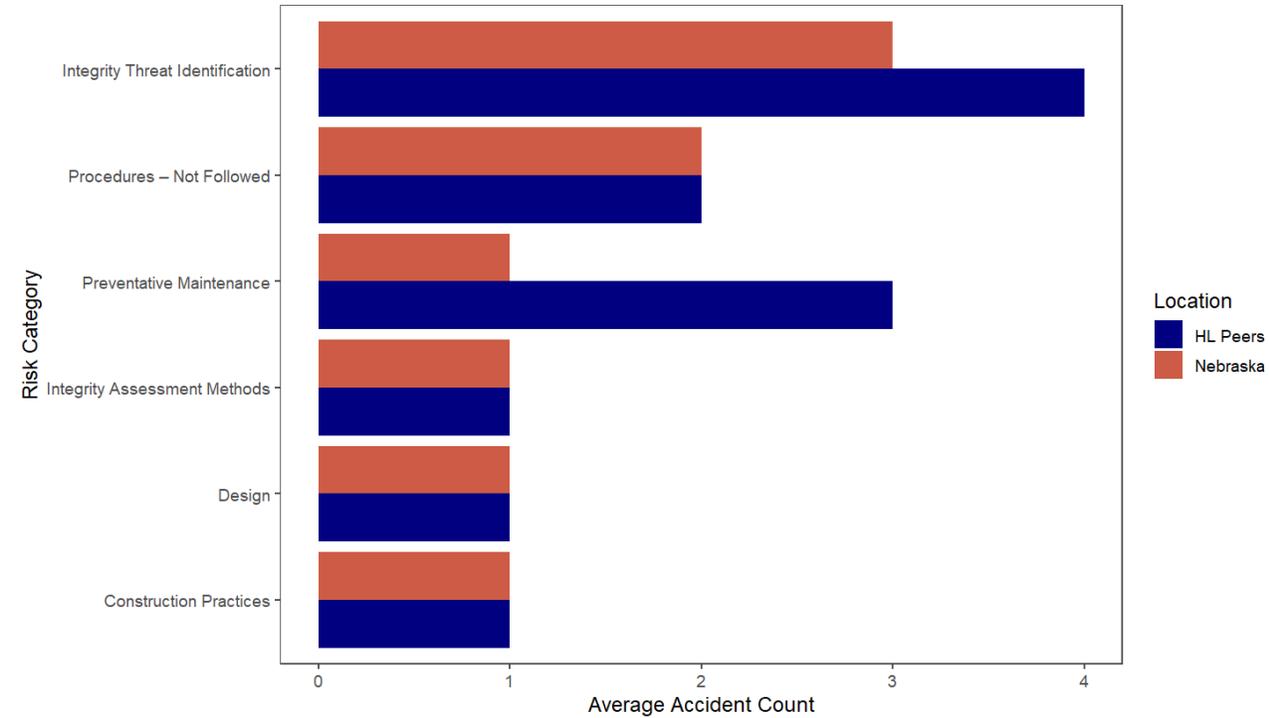
Nebraska Risk Categories Compared to the Average for 4 HL Peers

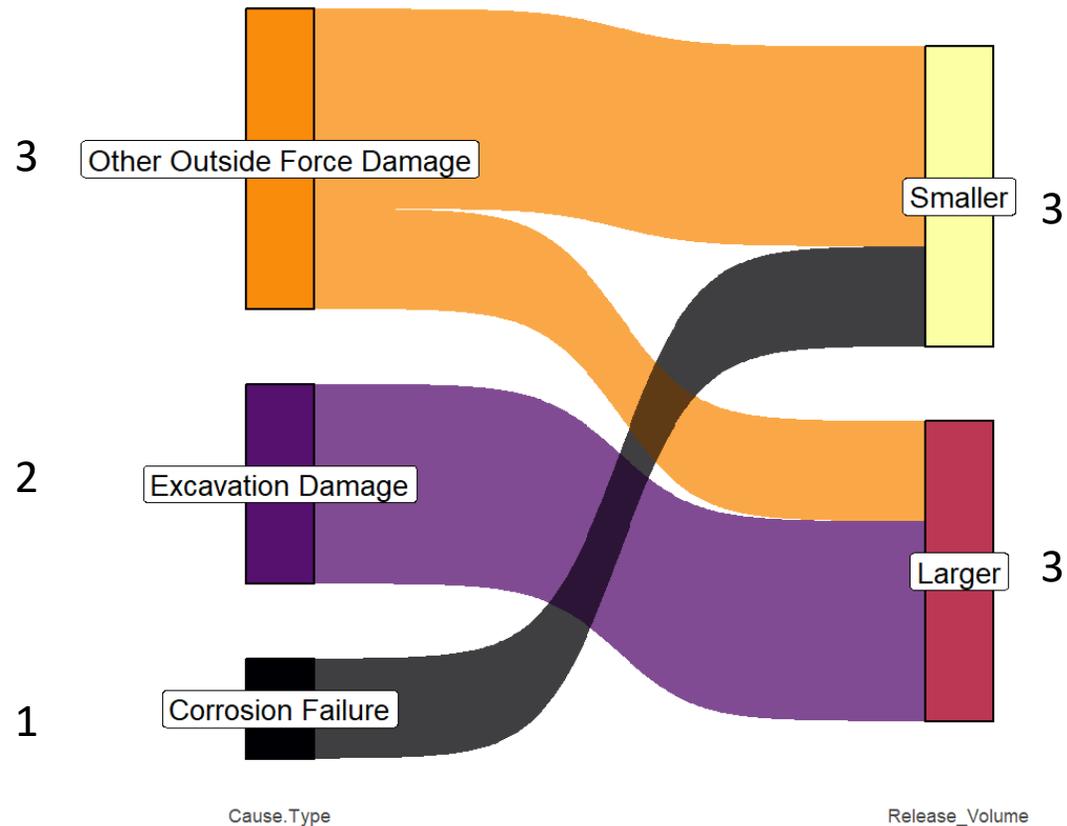
Nebraska GD Incident Cause Type and Release Volume Above/Below the Median

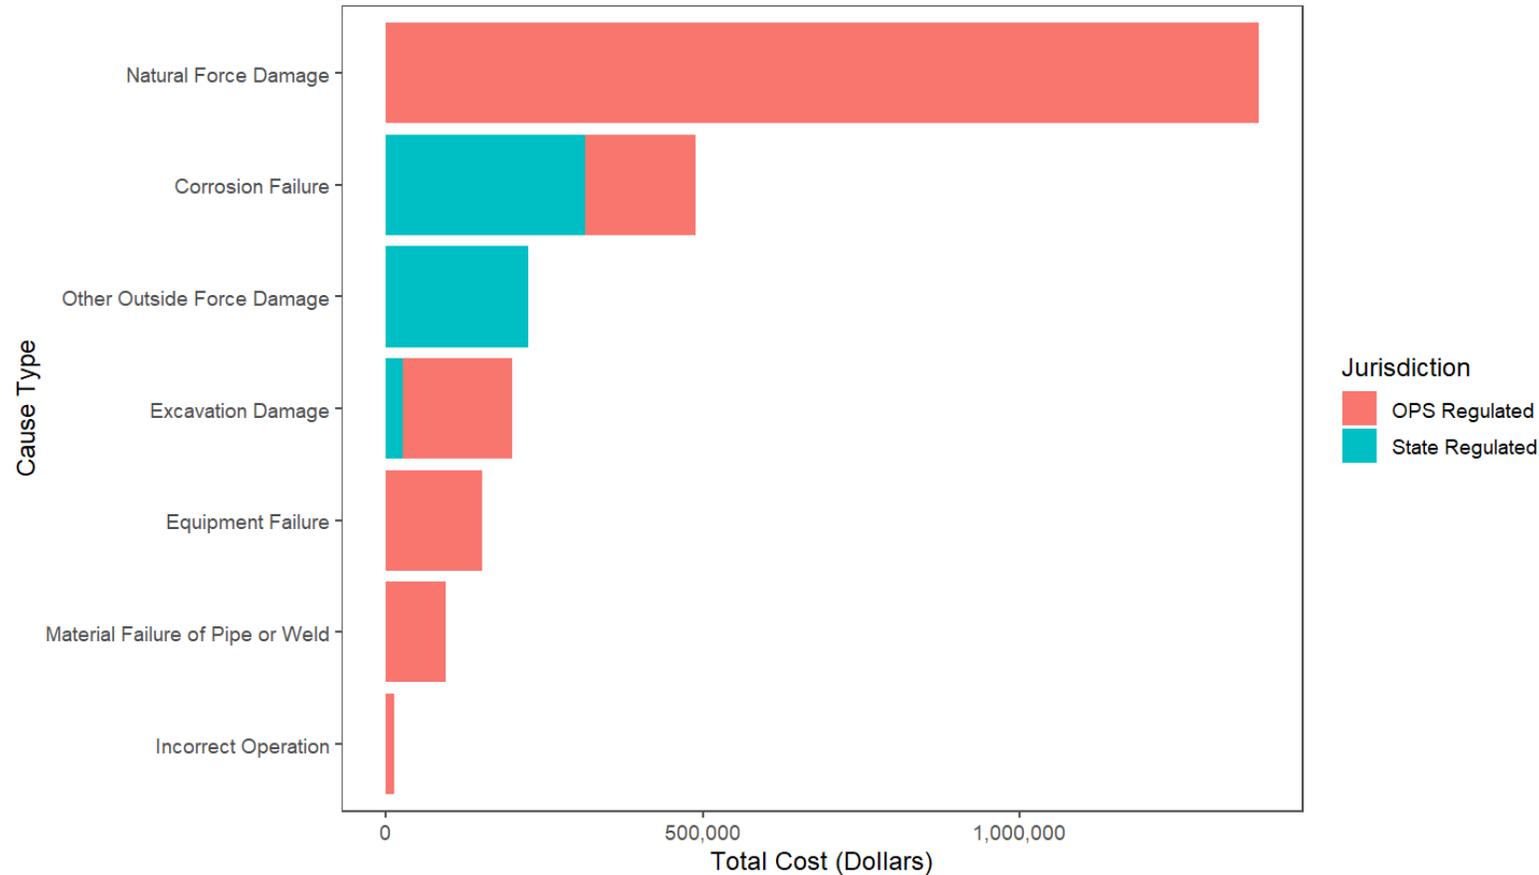
Nebraska Failure Costs By Cause Type

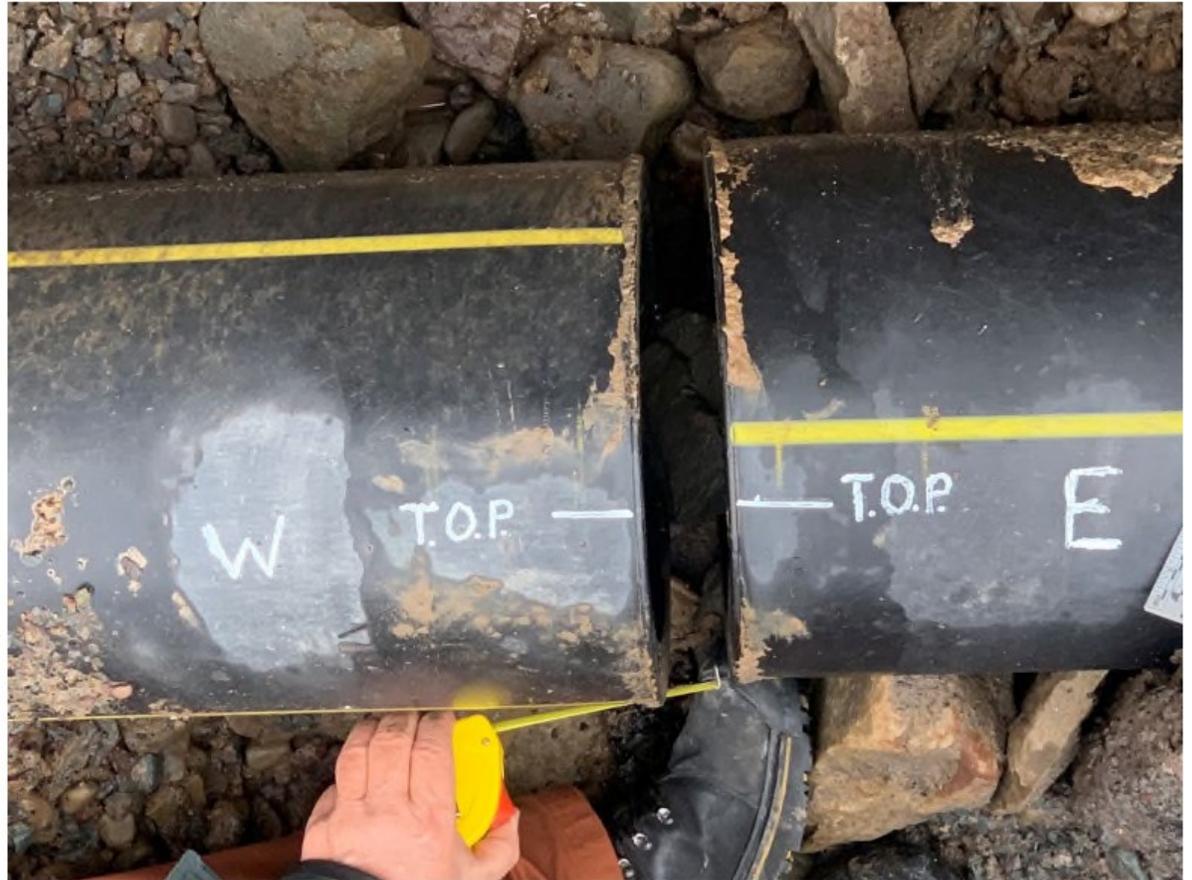
- Rupture of 12-inch HDPE, installed in 2019
- Emergency responder notification
- Release of natural gas, operating at 95 psig
- A main road was damaged, causing a vehicle to overturn
- The incident was caused by butt fusion failure
- Inadequate interfacial pressure during the fusion process
- And/or excessive dwell time between heat soak and joining phases
- Failure to follow appropriate installation and inspection procedures

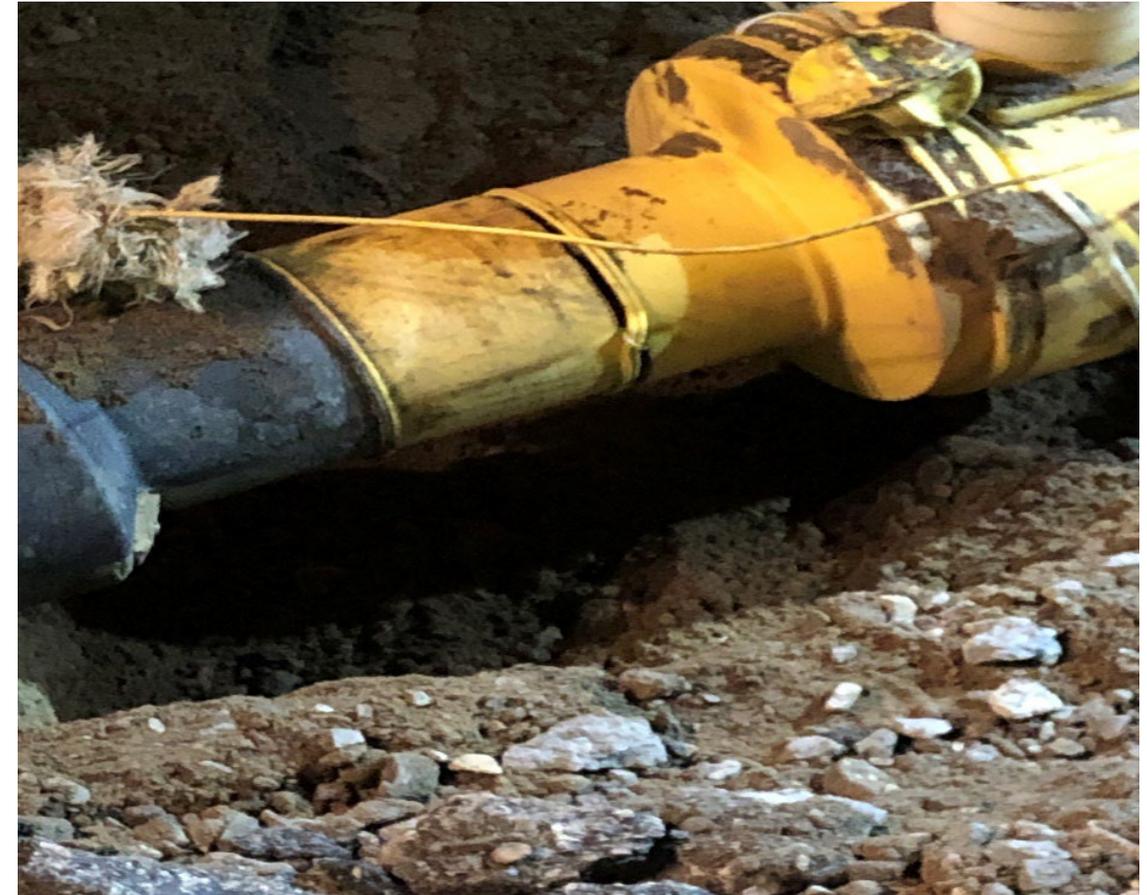
- Failure at an assembly, including an 8-inch PE pipe, an 8-inch PE valve, and an 8-inch to 12-inch transition fitting.
- Emergency responder made the notification
- This assembly was installed in 2019
- Main was operating at 43 psig
- There were no injuries or fatalities
- The incident was caused by butt fusion failure
- The melt surface on the 8-inch pipe had a concave appearance
- It may have been caused by excessive pressure during the fusion process or a cold fusion
- Construction practices: poor workmanship

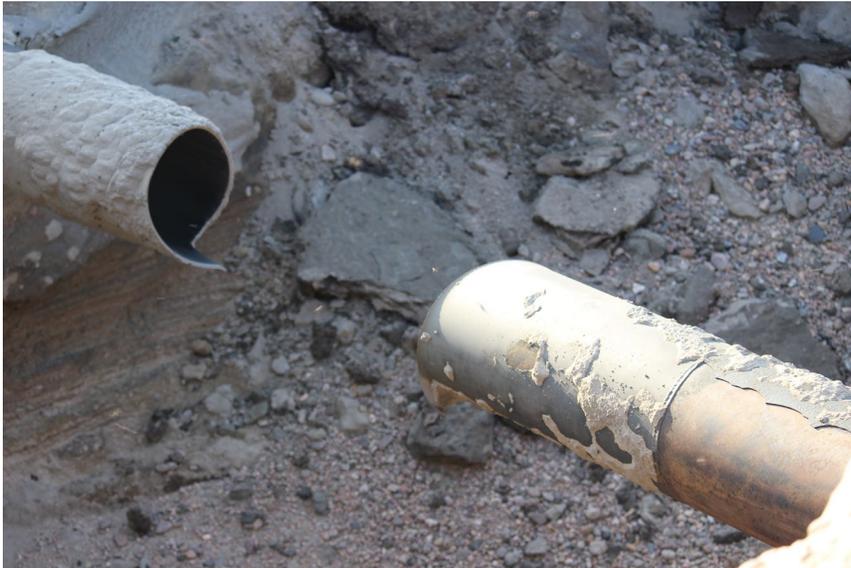
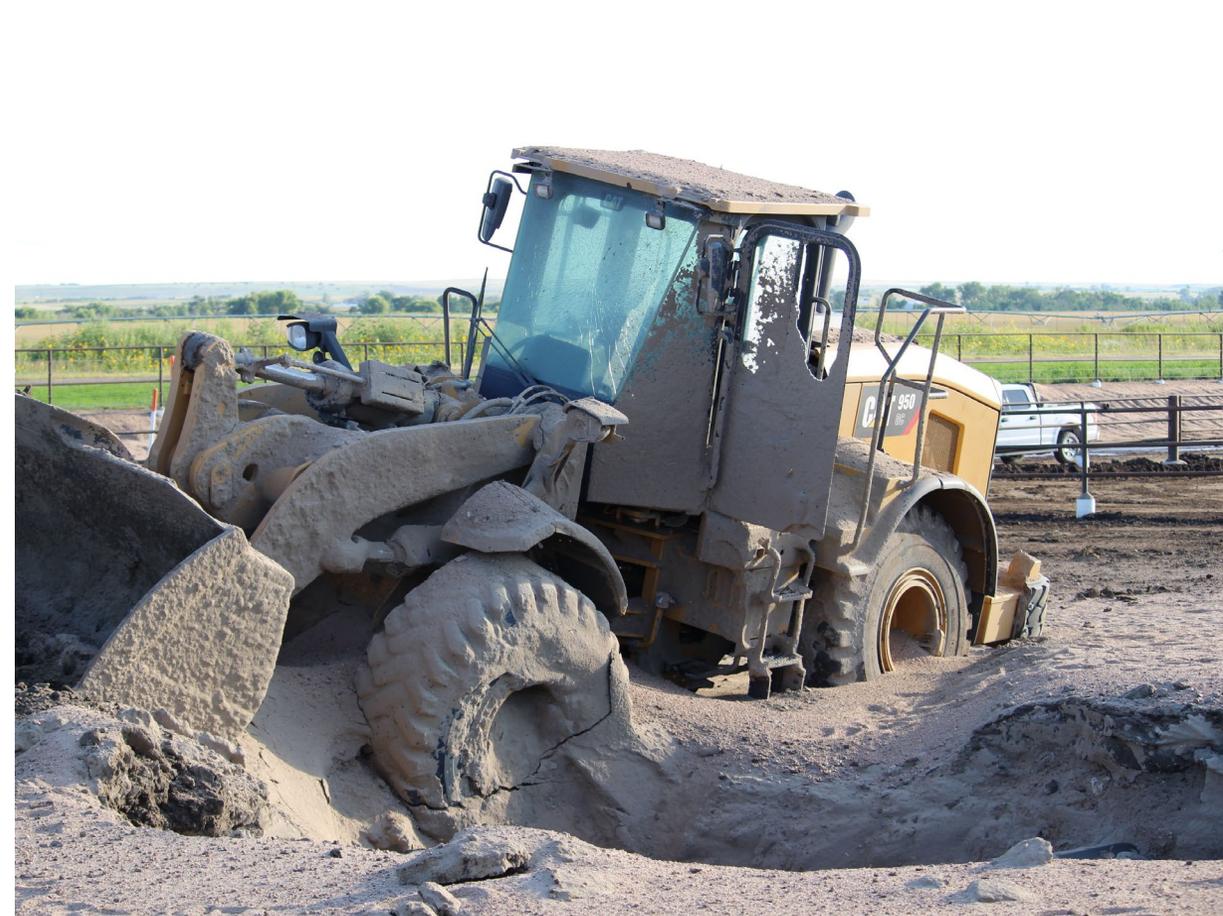
- A third-party wheel loader struck the 10-inch pipeline within a cattle feedlot during maintenance operations.
- The third party did not make a One-Call.
- Investigation is on-going.

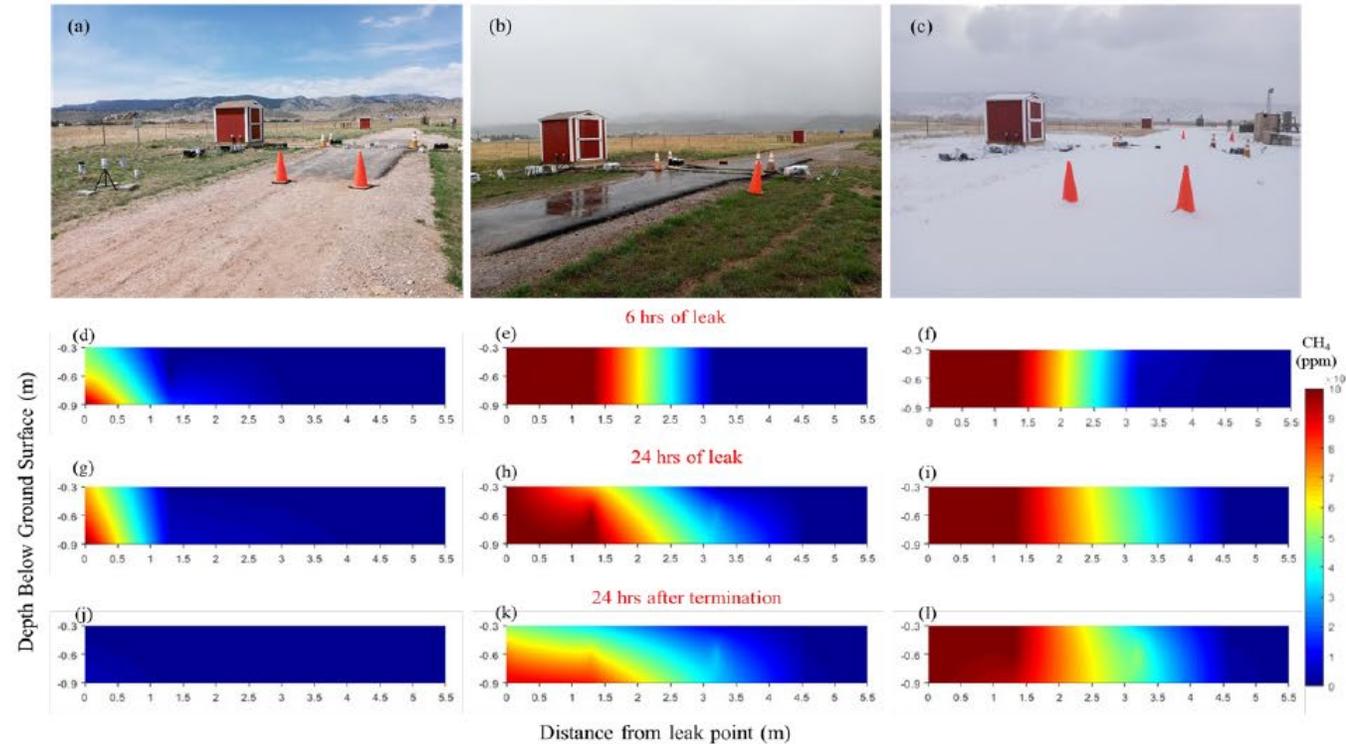
## Example: Effect of Surface Cover

LEL = 50,000 ppm (5% CH<sub>4</sub> V/V)

14 UEL = 150,000 ppm (15% CH<sub>4</sub> V/V)

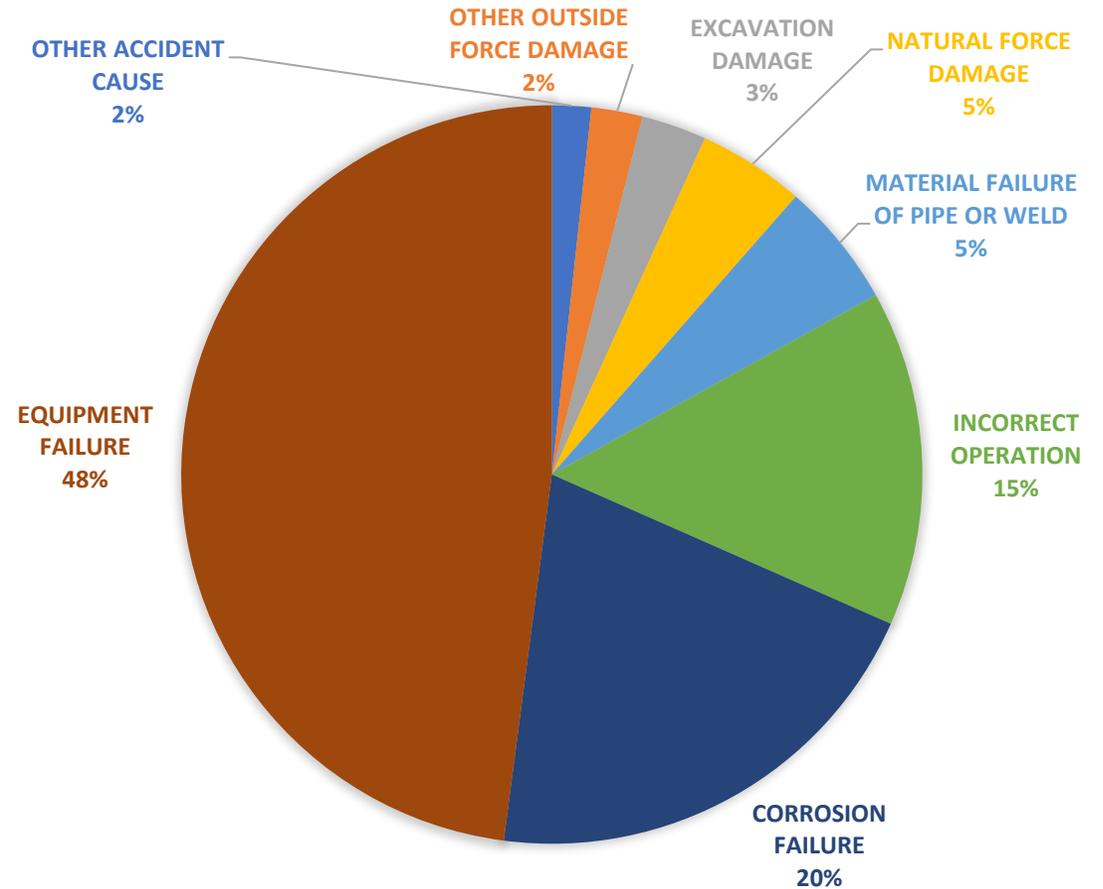
# Hazardous Liquid Accidents (2018 – August 2023)

<b>EQUIPMENT FAILURE</b>	<b>926</b>
NON-THREADED CONNECTION FAILURE	292
PUMP OR PUMP-RELATED EQUIPMENT	177
THREADED CONNECTION/COUPLING FAILURE	144
MALFUNCTION OF CONTROL/RELIEF EQUIPMENT	116
OTHER EQUIPMENT FAILURE	110
DEFECTIVE OR LOOSE TUBING OR FITTING	49
FAILURE OF EQUIPMENT BODY (EXCEPT PUMP), TANK PLATE, OR OTHER MATERIAL	38

<b>CORROSION FAILURE</b>	<b>395</b>
INTERNAL CORROSION	259
EXTERNAL CORROSION	136

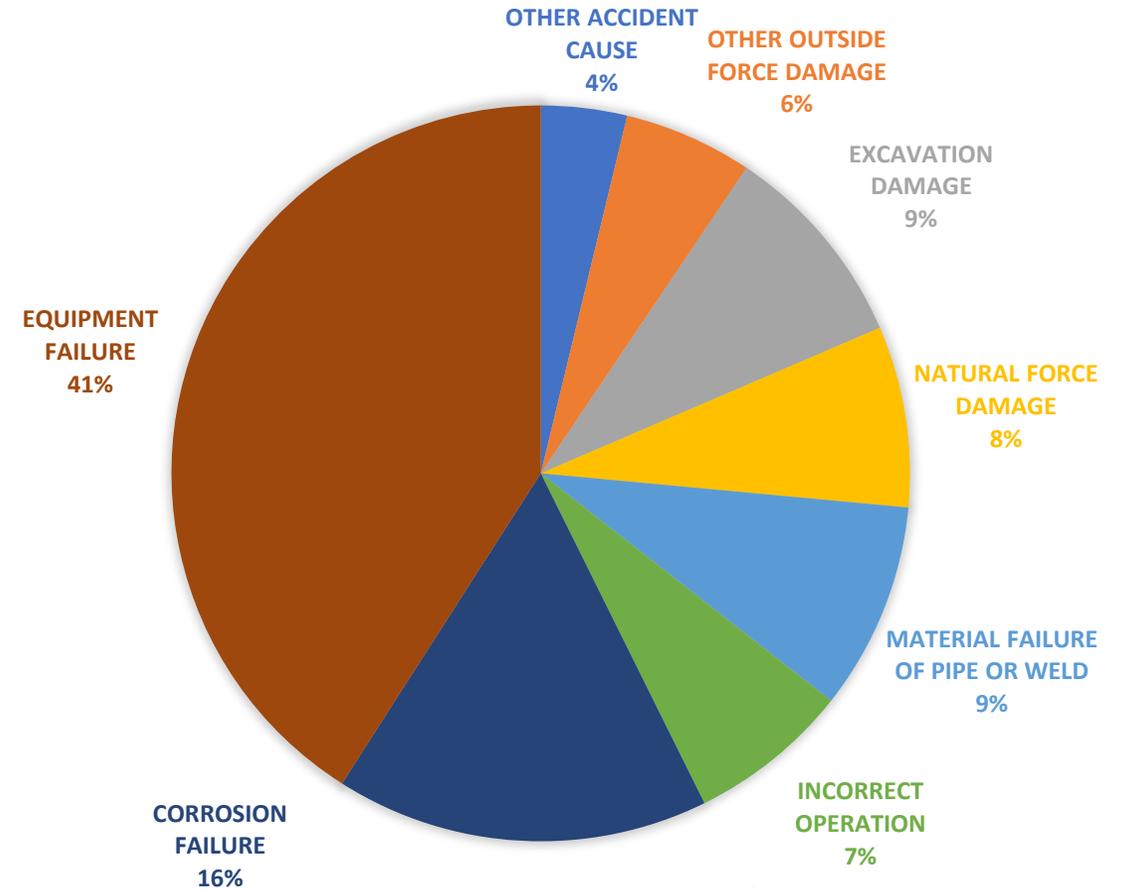
# Gas Transmission Incidents (2018 – August 2023)

<b>EQUIPMENT FAILURE</b>	<b>283</b>
MALFUNCTION OF CONTROL/RELIEF EQUIPMENT	180
OTHER EQUIPMENT FAILURE	28
THREADED CONNECTION/COUPLING FAILURE	26
NON-THREADED CONNECTION FAILURE	19
COMPRESSOR OR COMPRESSOR-RELATED EQUIPMENT	15
DEFECTIVE OR LOOSE TUBING OR FITTING	11
FAILURE OF EQUIPMENT BODY (EXCEPT COMPRESSOR), VESSEL PLATE, OR OTHER MATERIAL	4

<b>CORROSION FAILURE</b>	<b>113</b>
INTERNAL CORROSION	61
EXTERNAL CORROSION	52

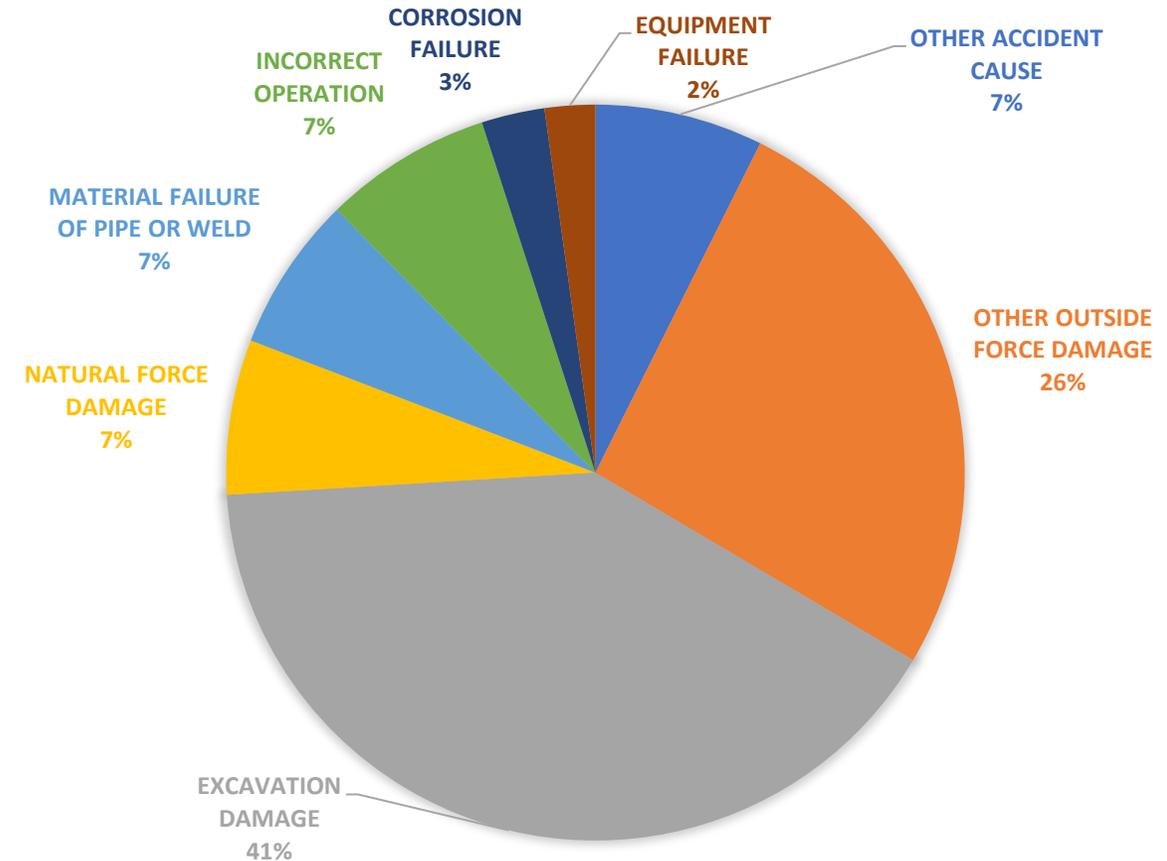
# Gas Distribution Incidents (2018 – August 2023)

<b>EXCAVATION DAMAGE</b>	<b>220</b>
THIRD PARTY	191
OPERATOR'S CONTRACTOR (SECOND PARTY)	15
PREVIOUS DAMAGE DUE TO EXCAVATION ACTIVITY	9
OPERATOR (FIRST PARTY)	5

<b>EXCAVATION DAMAGE</b>	<b>220</b>
EXCAVATION PRACTICES NOT SUFFICIENT	108
LOCATING PRACTICES NOT SUFFICIENT	53
ONE-CALL NOTIFICATION PRACTICES NOT SUFFICIENT	45
OTHER	7
PREVIOUS DAMAGE	4
DATA NOT COLLECTED	3
EXCAVATION DAMAGE	220

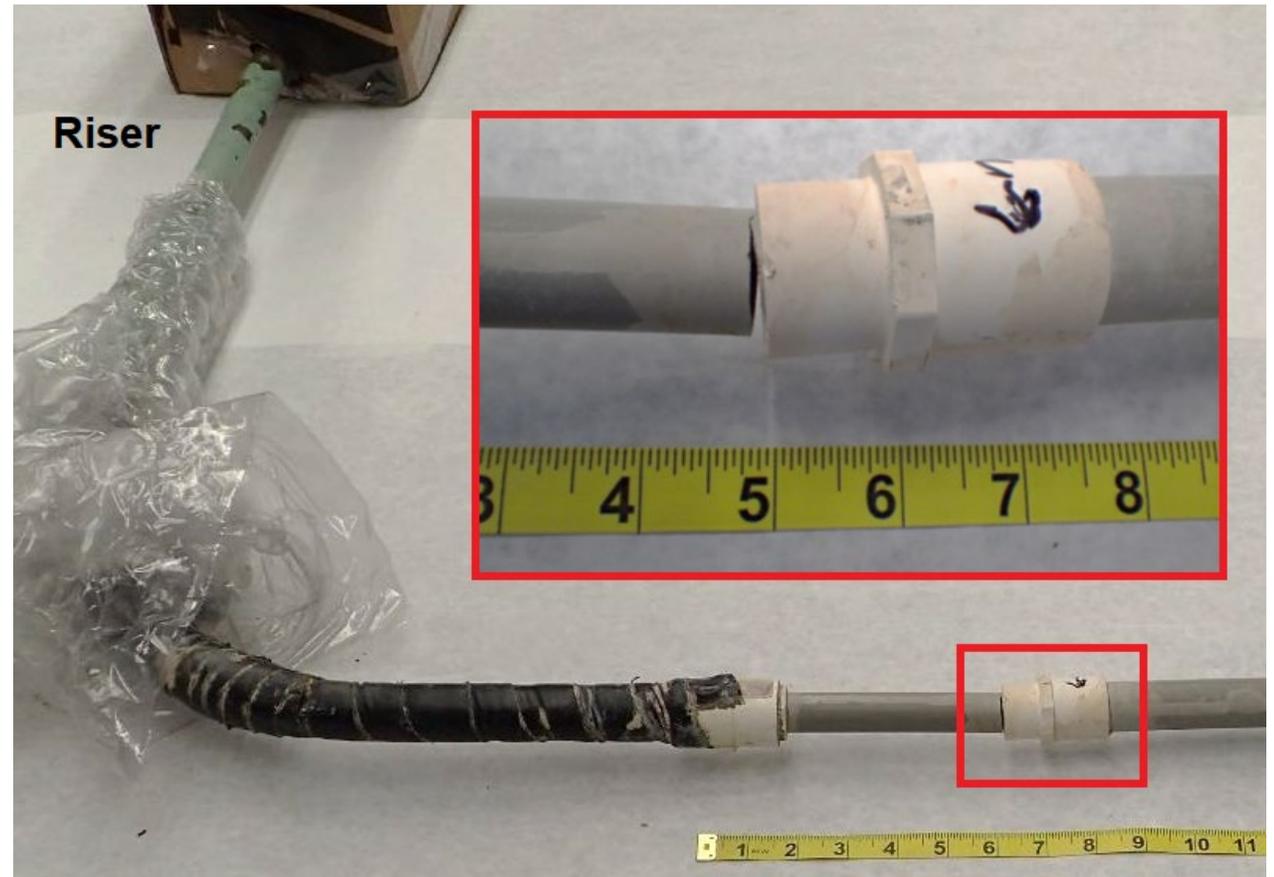
- Natural gas leak detected during an annual PVC leak survey, near a laundry room riser
- Gas reads indicated 1-4% LEL by the riser
- Meter was turned off, but ignition occurred inside the building
- After ignition, gas leak measurements were still increasing, 14 people and adjacent units were evacuated
- Failure of 1973 ½-inch PVC service pipeline
- The line was operating at 39 psig
