# Pipeline and Hazardous Materials Safety Administration (PHMSA)

### Accident Investigation Division (AID)

Nebraska State Fire Marshal Pipeline Safety Seminar

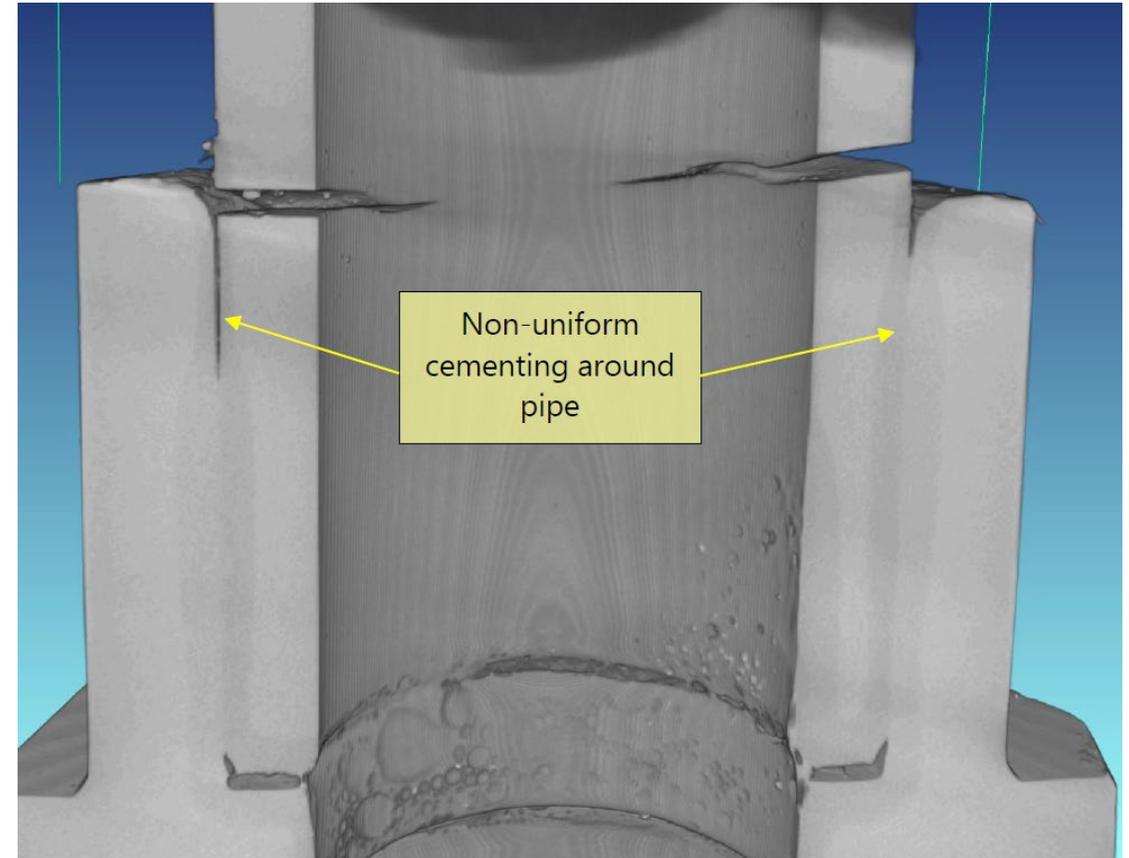
- Circumferential crack near the edge of the joint bond between the ½-inch pipe and the reducer fitting
- Non-uniform cementing around the joint
- The crack initiation area was at the bottom of the pipe's outer diameter
- The fracture surface exhibited smooth features, indicative of brittle fracture, slow crack growth, and creep rupture
- The field investigation determined that the bending loads may have been caused by a customer houseline water leak, which eroded the support from under the service line's transition fitting.

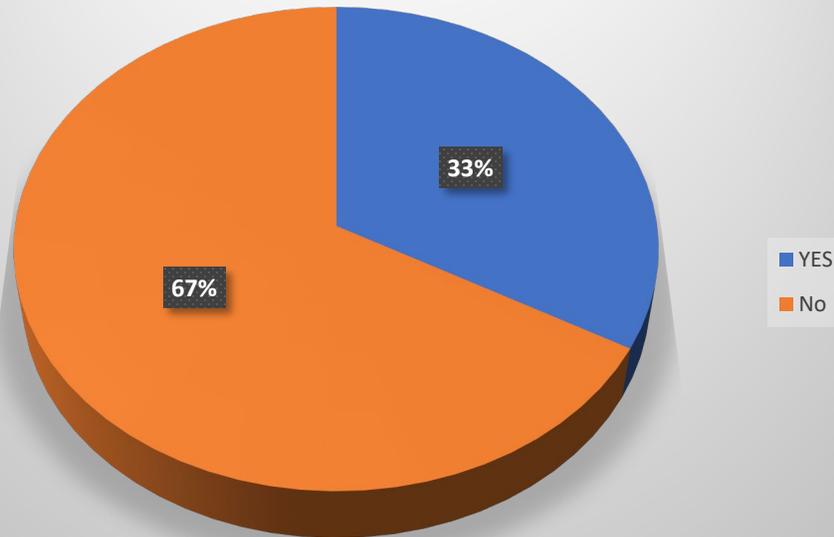
Was a CIS done on the HL pipeline with external corrosion failure?

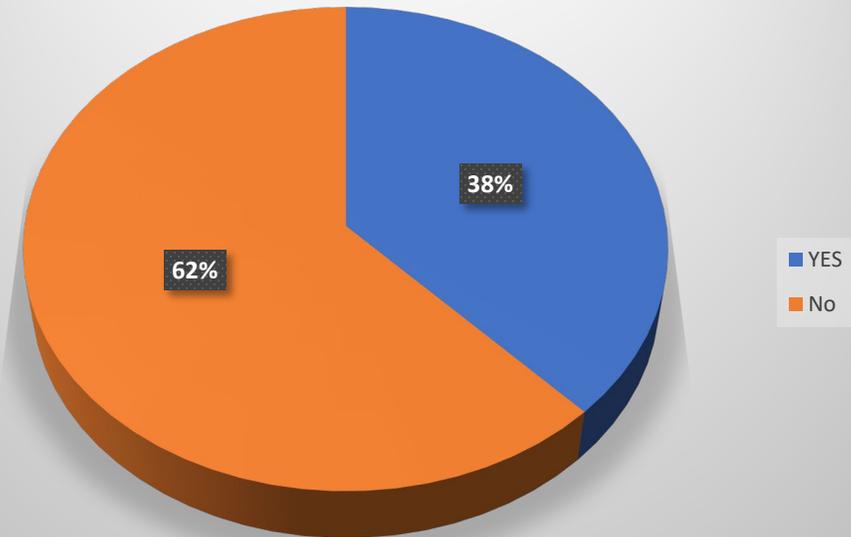
Was a CIS done on the GT pipeline with external corrosion failure?
