Nebraska State Fire Marshal Pipeline Safety Section Investigation Report

INCIDENT INVESTIGATION

Black Hills Energy

Geneva

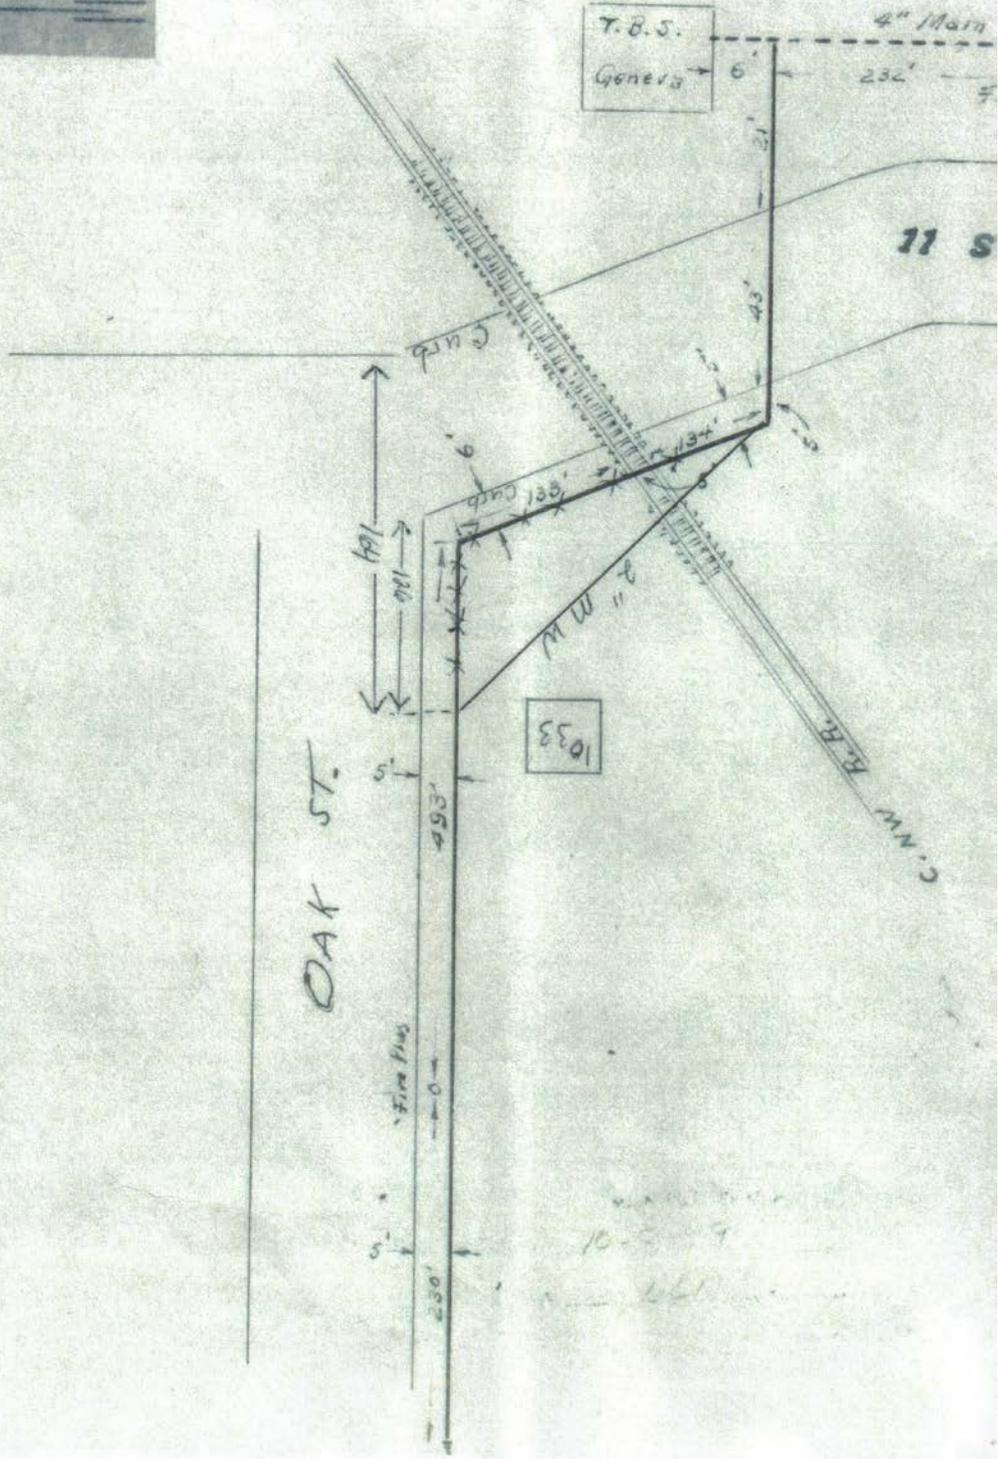
4" Main

In reality, the new 2" 2406 PE main was connected to a 6" PE 3408 gas main operating at 52 psig (60 MAOP)

Existing 2" system serves approximately 31 customers operating at 15 psig system (which is the MAOP), is steel main with combination steel and PE services. The existing 2" steel mw main was connected to a tap on a 4" bare steel main, located near "old" TBS site.
